TOWN OF SOUTHERN PINES WATER ASSET MANAGEMENT PLAN

February 2026

NC DEQ Project No. AIA-D-ARP-0062

WR Project No. 02220448.01

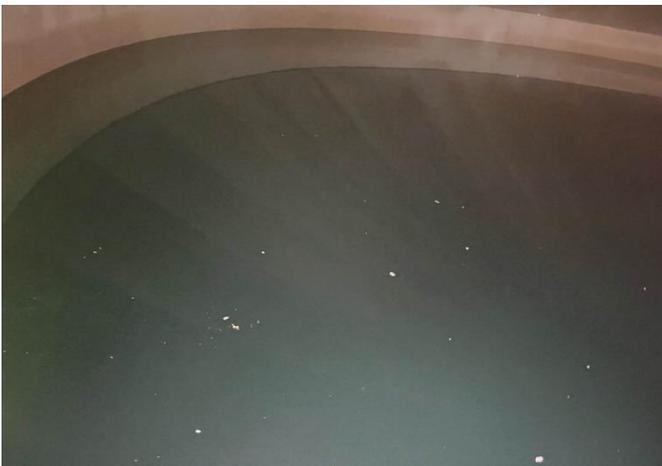
Interior Sidewall Coating

- **Interior Coating Condition:** Visible areas of the Interior lining are in good condition and continues to protect the substrate.
- **Exterior Coating Condition:** No deficiencies noted in the exterior coating.

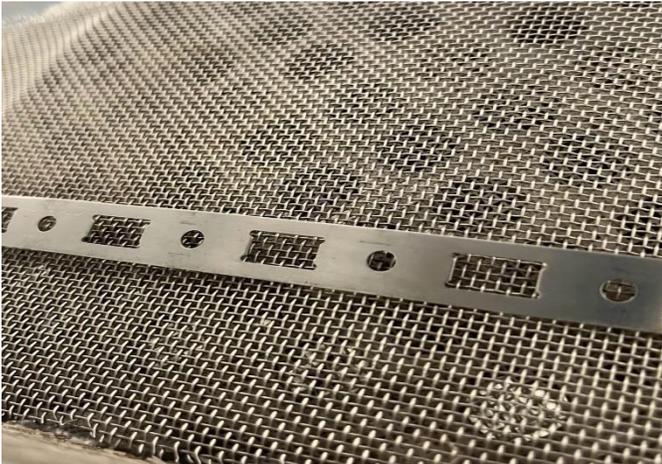
Vent Screen

- **Vent Screen:** Vent screen was replaced during the inspection.
- **Evidence Of Foreign Matter:** No evidence of foreign matter observed.
- **Sediments:** Sediment was present in the bottom of the tank and will be cleaned out at the next scheduled washout.

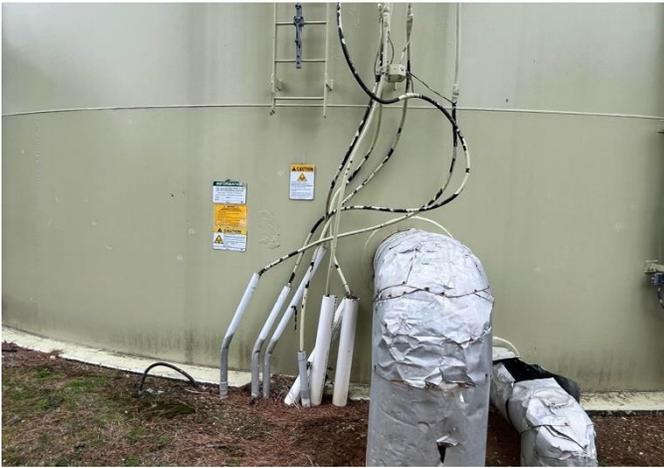
- **Foundation:** Foundation appears in good condition. No deficiencies noted.
- **Access Ladders:** No deficiencies noted for dry-side access ladder stiles, rungs and connections.
- **Watertight Conditions:** There are no visible leaks at manway, riser or legs.
- **Interior Ladders:** Interior ladder partially inspected from hatch. No deficiencies noted with visible portion of ladder.
- **Roof:** The interior roof does not have roof beams. No deficiencies noted.
- **Vents:** No deficiencies noted with vent.
- **Overflow Pipe:** No deficiencies noted. Overflow pipe extends to ground level.
- **Welds:** No deficiencies noted with weld seams.
- **Float System:** Float system is in working condition. No deficiencies noted.
- **Level Indicator:** Level indicator is in working condition with no deficiencies noted.

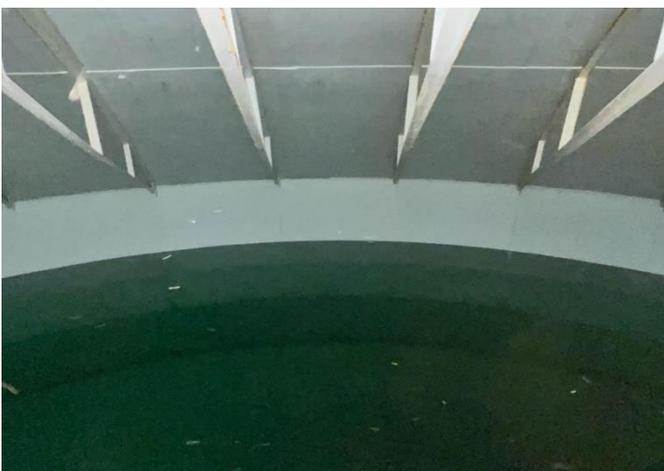
Interior Roof and Sidewall Coating

- **Interior Coating Condition:** Visible areas of the interior coating are in good condition and continues to protect the substrate.
- **Exterior Coating Condition:** No deficiencies noted in the exterior coating.
- **Dry Interior Condition:** No deficiencies noted in the dry interior coating.

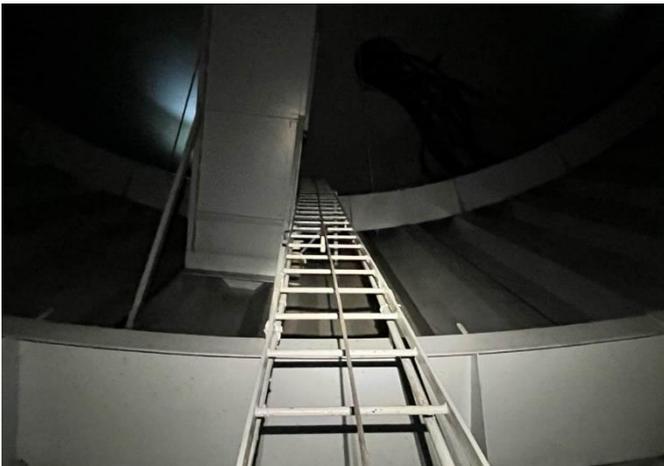
Safety Climb on Access Ladder

- **Safety Climbing Devices:** Ladders are equipped with secured safety climb devices.
- **Access Hatch1:** No deficiencies noted with the dry interior roof access hatch.
- **Access Hatch2:** Minor deficiencies noted with the wet interior roof access hatch. We will continue to monitor these areas.

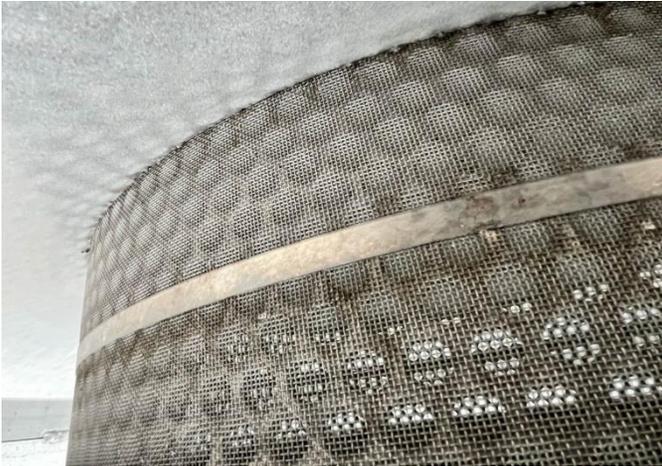
Roof Vent Screen

- **Vent Screen:** No deficiencies noted with vent screen.
- **Overflow Pipe Screen Flapper:** Overflow pipe is equipped with flap gate. No deficiencies noted with flapper.
- **Evidence Of Foreign Matter:** No evidence of foreign matter observed.
- **Sediments:** Sediment is present in the bottom of the tank and will be cleaned out at the next washout.

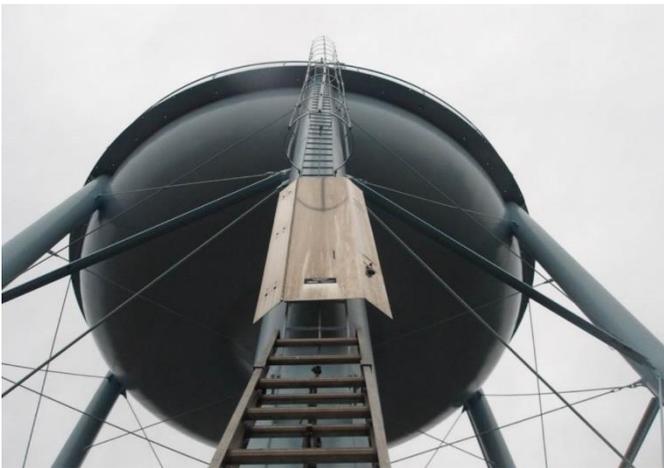
Ladder with Safety Climb Device

- **Safety Climbing Devices:** Ladders are equipped with secured safety climb devices.
- **Access Hatch:** Corrosion deficiencies noted on the interior portion of the access hatch. Areas will be addressed at the tentatively scheduled interior renovation.

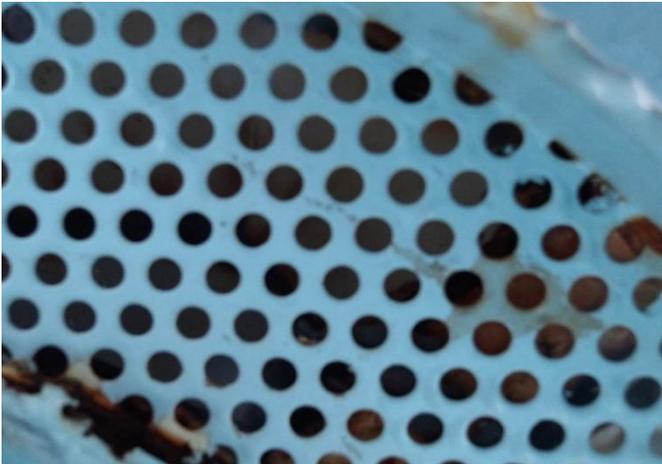
Roof Vent Screen

- **Vent Screen:** No deficiencies noted with vent screen.
- **Evidence of Foreign Matter:** No evidence of foreign matter observed.
- **Sediments:** Sediment was present in the bottom of the tank and will be cleaned at the next scheduled washout.

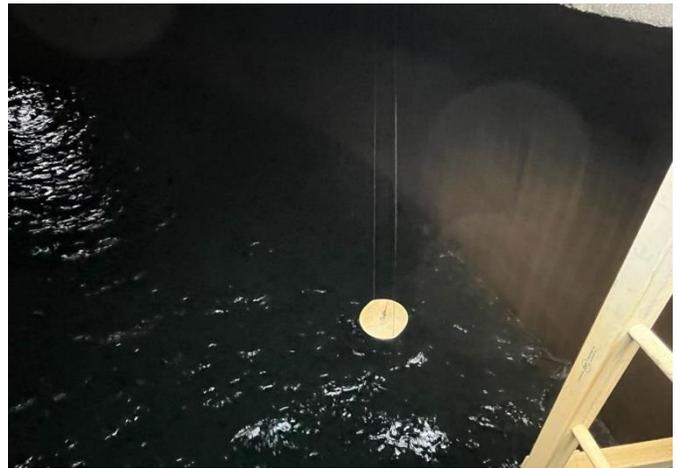
Interior Condition

- **Interior Coating Condition:** No interior coating present.
- **Exterior Coating Condition:** No deficiencies noted in the exterior coating.

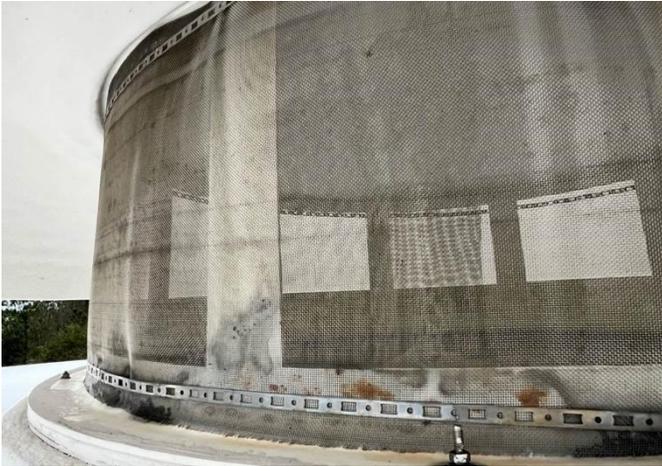
Vent Screen 1

- **Vent Screen:** No deficiencies noted with vent screen.
- **Overflow Pipe Screen Flapper:** Overflow pipe is equipped with screen. No deficiencies noted with screen.
- **Evidence Of Foreign Matter:** No evidence of foreign matter observed.
- **Sediments:** Sediment was present in the bottom of the tank and will be cleaned out at the next scheduled washout.

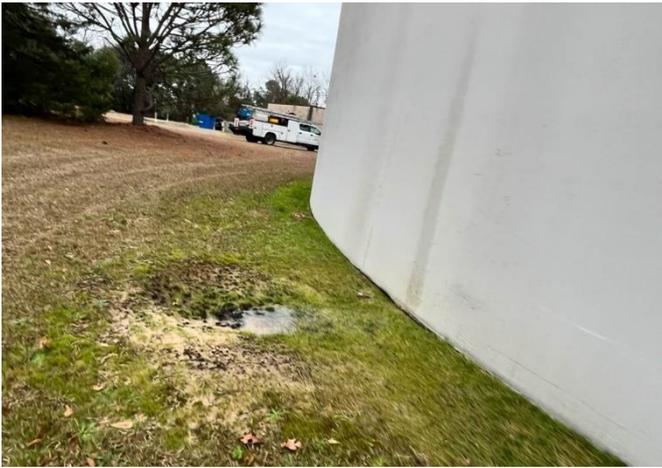
- **Foundation:** Foundation appears in good condition. No deficiencies noted
- **Access Ladders:** No deficiencies noted for dry-side access ladder stiles, rungs and connections.
- **Watertight Conditions:** There are no visible leaks at manway, riser or legs.
- **Interior Ladders:** Interior ladder partially inspected from hatch. No deficiencies noted with visible portion of ladder.
- **Roof:** Interior roof structure partially inspected from hatch. No deficiencies noted with roof structure.
- **Vents:** No deficiencies noted with vent.
- **Overflow Pipe:** No deficiencies noted. Overflow pipe extends to ground level.
- **Float System:** Float system is not working and will be scheduled for repair.
- **Level Indicator:** Level indicator is not working and will be scheduled for repair.
