**Southern Pines Waterworks Dam Siphon
Town of Southern Pines, NC**

ADDENDUM NO. 3

Inspection Report

Southern Pines Waterworks Dam - Intake Tower
Southern Pines, North Carolina

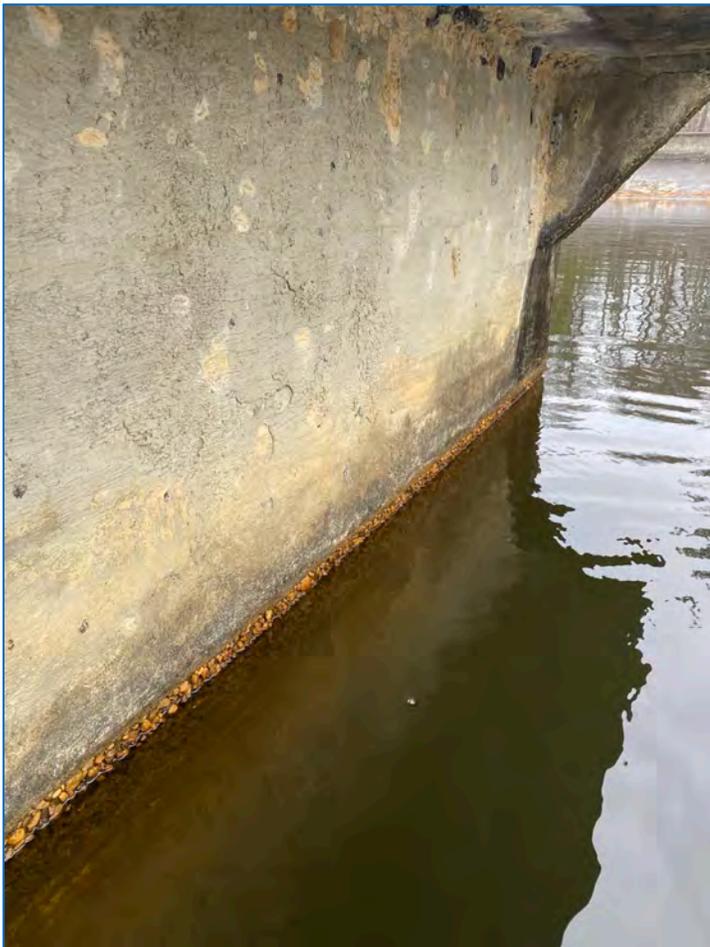
| Structure: | Condition: | Notes: |
|--|---|--|
| Concrete Control Tower | Fair | No significant issues, a few areas where the stems penetrate the tower ceiling are spalled. Slight pitting around the tower at the normal pool level. |

- The concrete surfaces surrounding the tower at the waterline showed signs of corrosion (Figure 17 & 18). The aggregate was exposed but no reinforcing was observed
- On the upstream tower exterior face, the concrete was spalled beneath each of the three operator holes for the water supply inlets (figure 19, 20, 21).
- Concrete was spalled on the interior tower ceiling directly beneath valve 5 (Figure 22)

Figure 17 – Right side tower face at water surface

The concrete control tower appears stable and a few minor upgrades, such as spall repairs and a concrete surface treatment, will extend its service life.

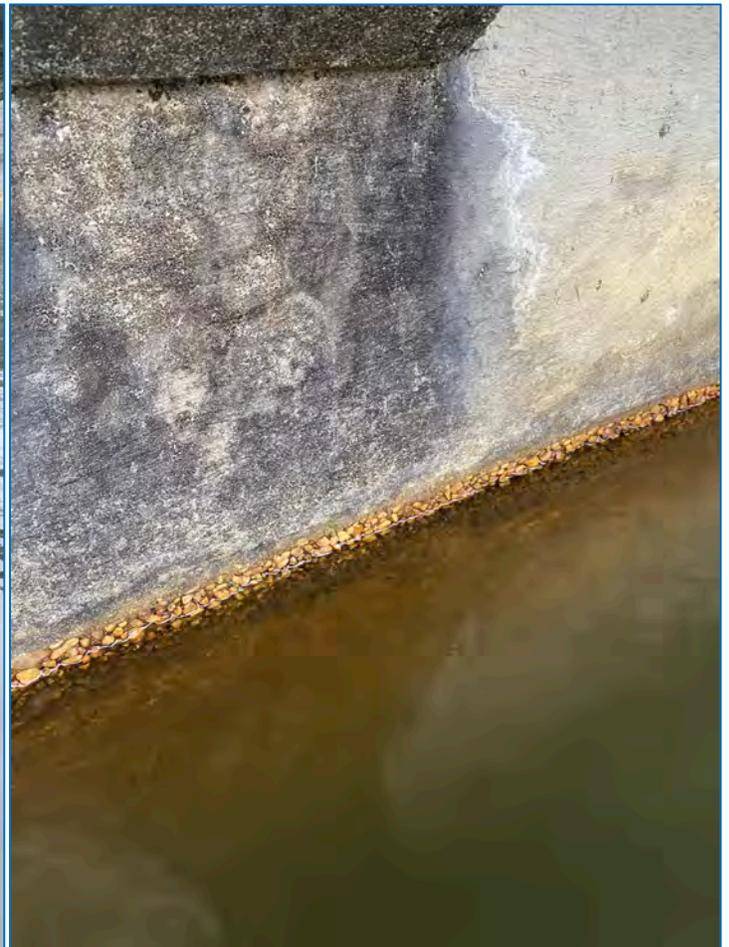
Figure 18 – Left side tower face

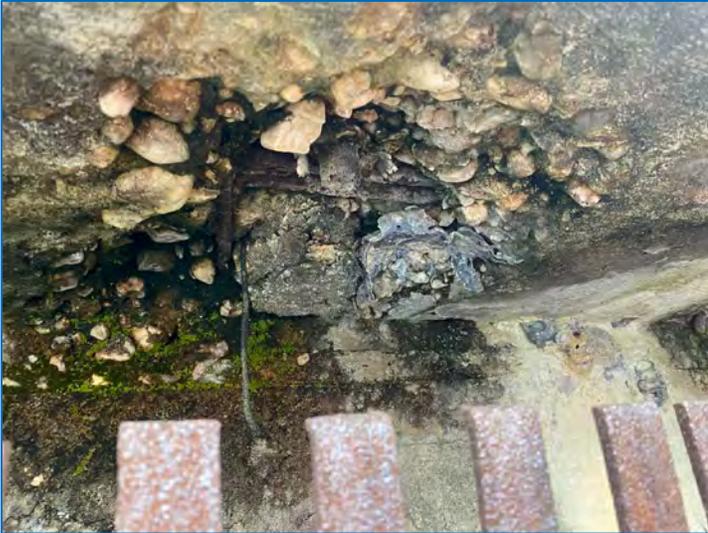
Figure 19 – Damage beneath Intake 2 Operator on exterior face

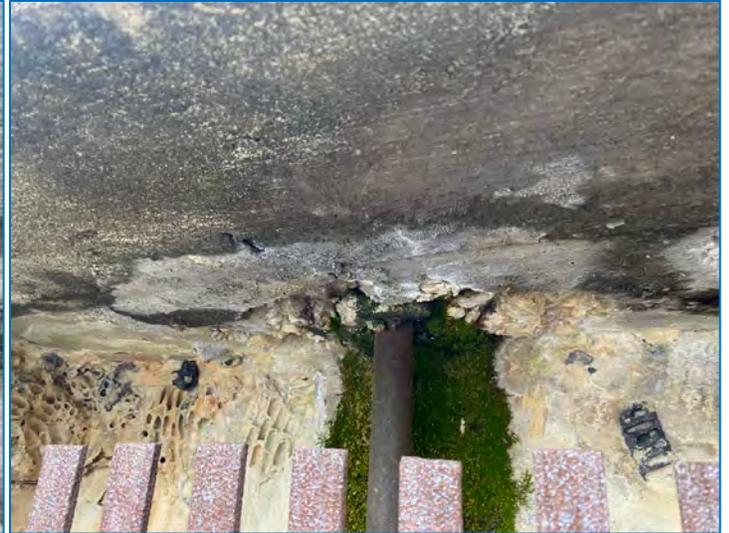
Figure 20 – Damage beneath Intake 1 Operator on exterior face

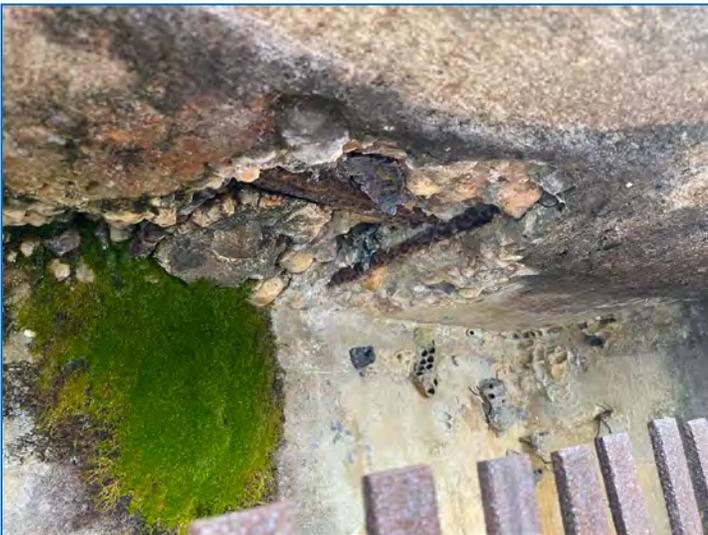
Figure 21 – Damage beneath Intake 3 Operator on exterior face

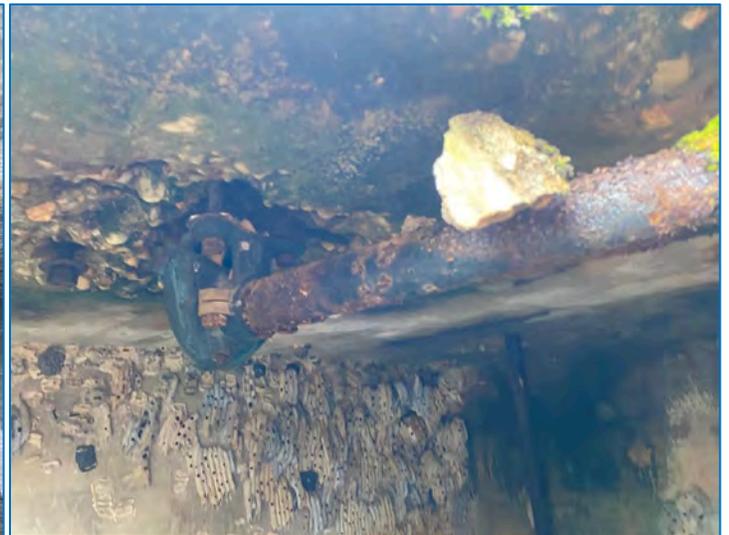
Figure 22 – Damage to concrete beneath Valve 5 operator

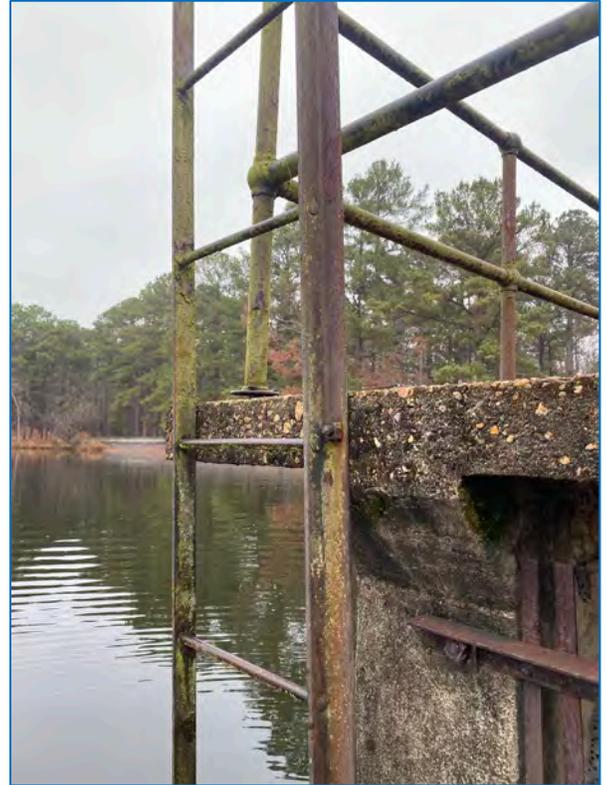
The access ladder on the upstream left side corner was loose (likely as designed) but secure. Minor deterioration was noted above water. The ladder extends down several inches below the lake surface and stops. It's unclear if a section of the ladder has broken off or simply the ends are heavily corroded. Access onto the tower was awkward, but functional.

Figure 25 - Access Ladder to tower

The access ladder and railings should be replaced if the tower will be returned to service. A new metal access grate with locking mechanism should be installed as soon as possible. This situation presents a fall hazard and is a liability.

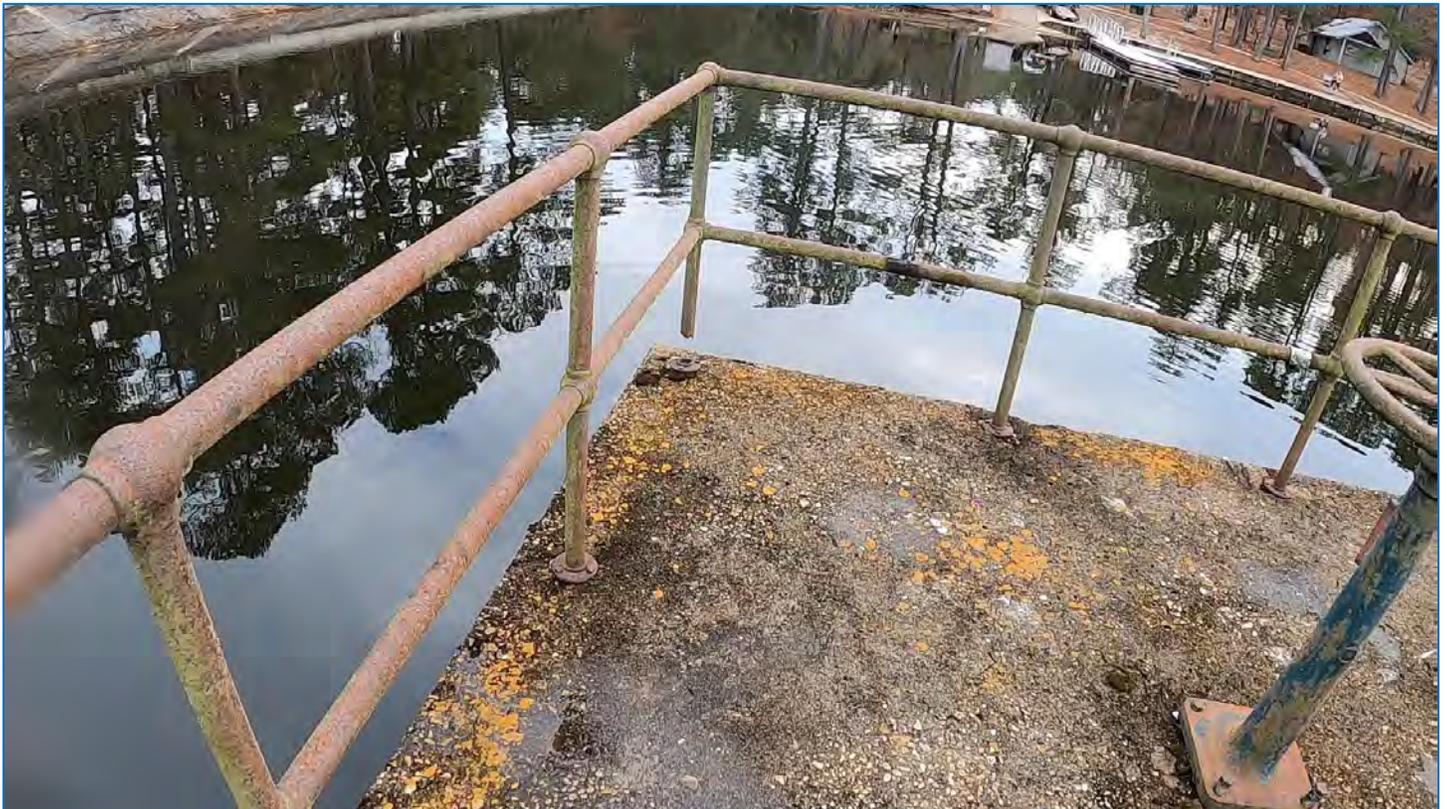
The metal handrails on the access platform were secure overall, however each corner post was compromised. Two of the posts were deteriorated and broken free while the other two appeared to have pulled up from the concrete.

Figure 26 – Handrail

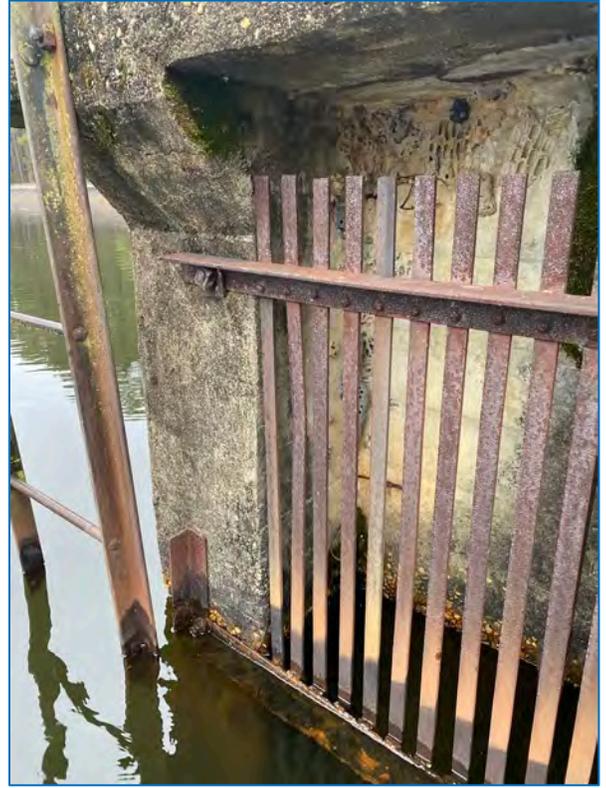
Roughly 50% of the rack is missing due to deterioration. The sections likely fell into the sediment. The rest of the metal was heavily corroded, especially near the water surface. The rack at lower depths appeared to be in better condition.

Figure 27 - Debris screen above water

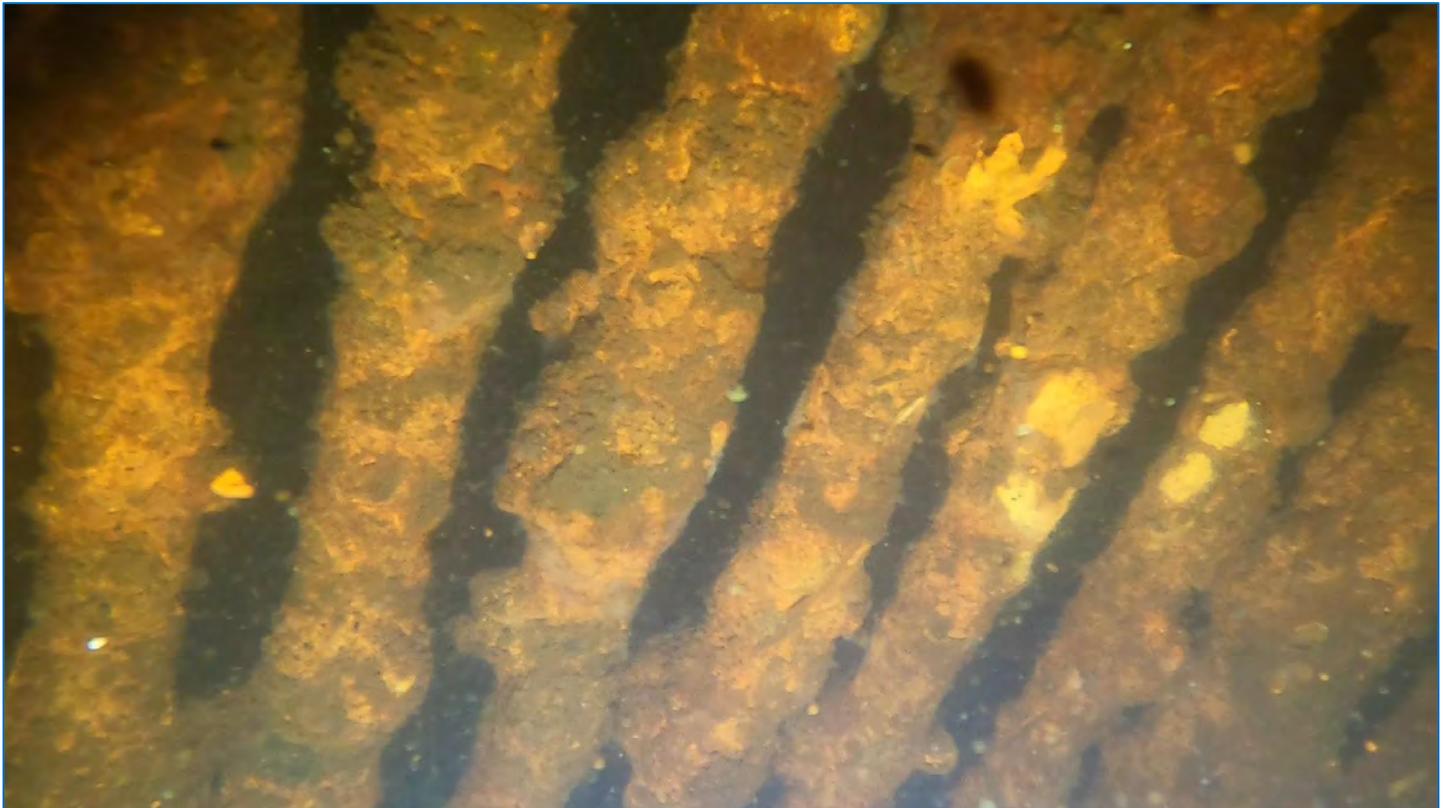
Figure 28 - Typical view of vertical flat bar that make of the debris screen near surface, typical

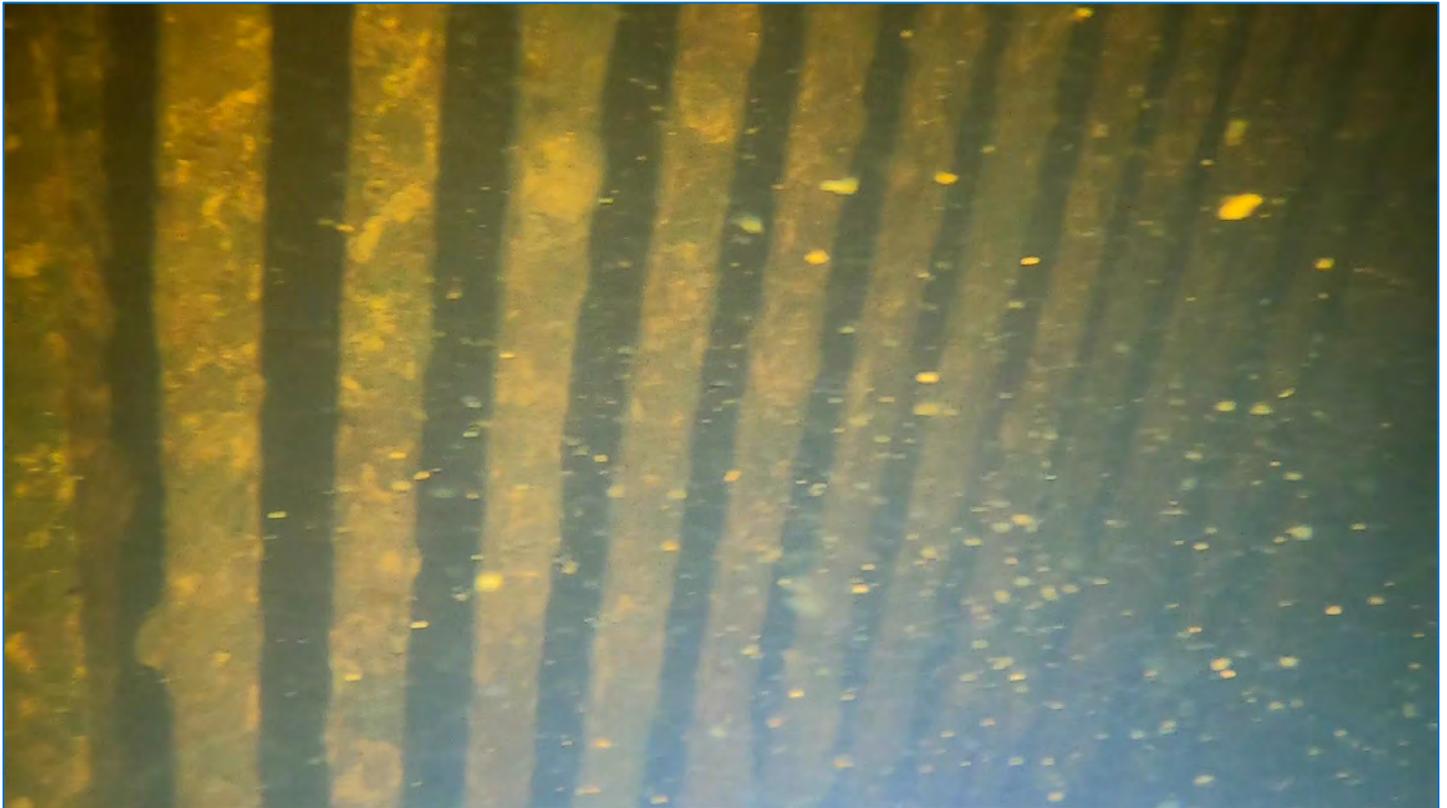
Figure 29 - Debris screen on upstream tower face, deeper depth, typical

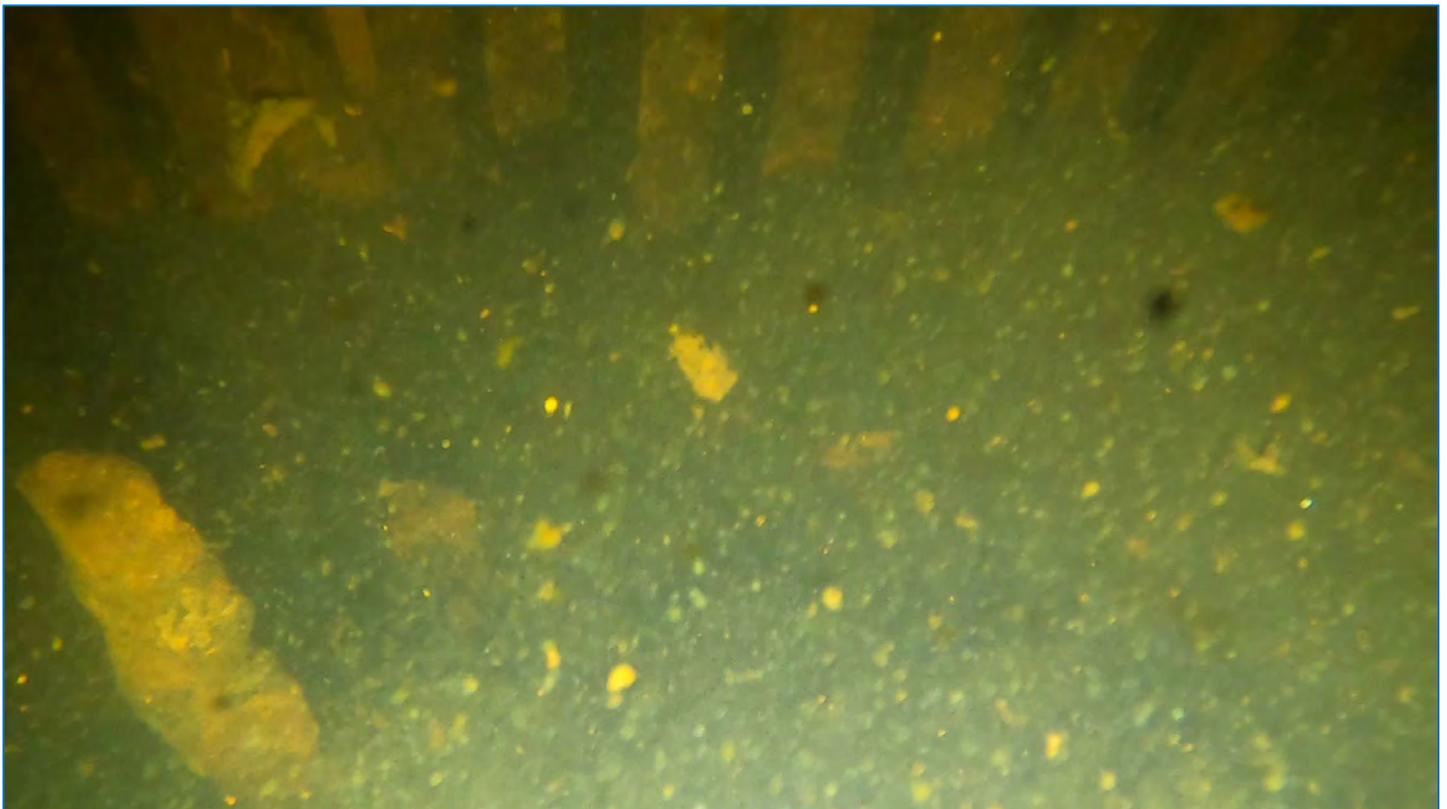
Figure 30 - Trash Screen disappears into sediment

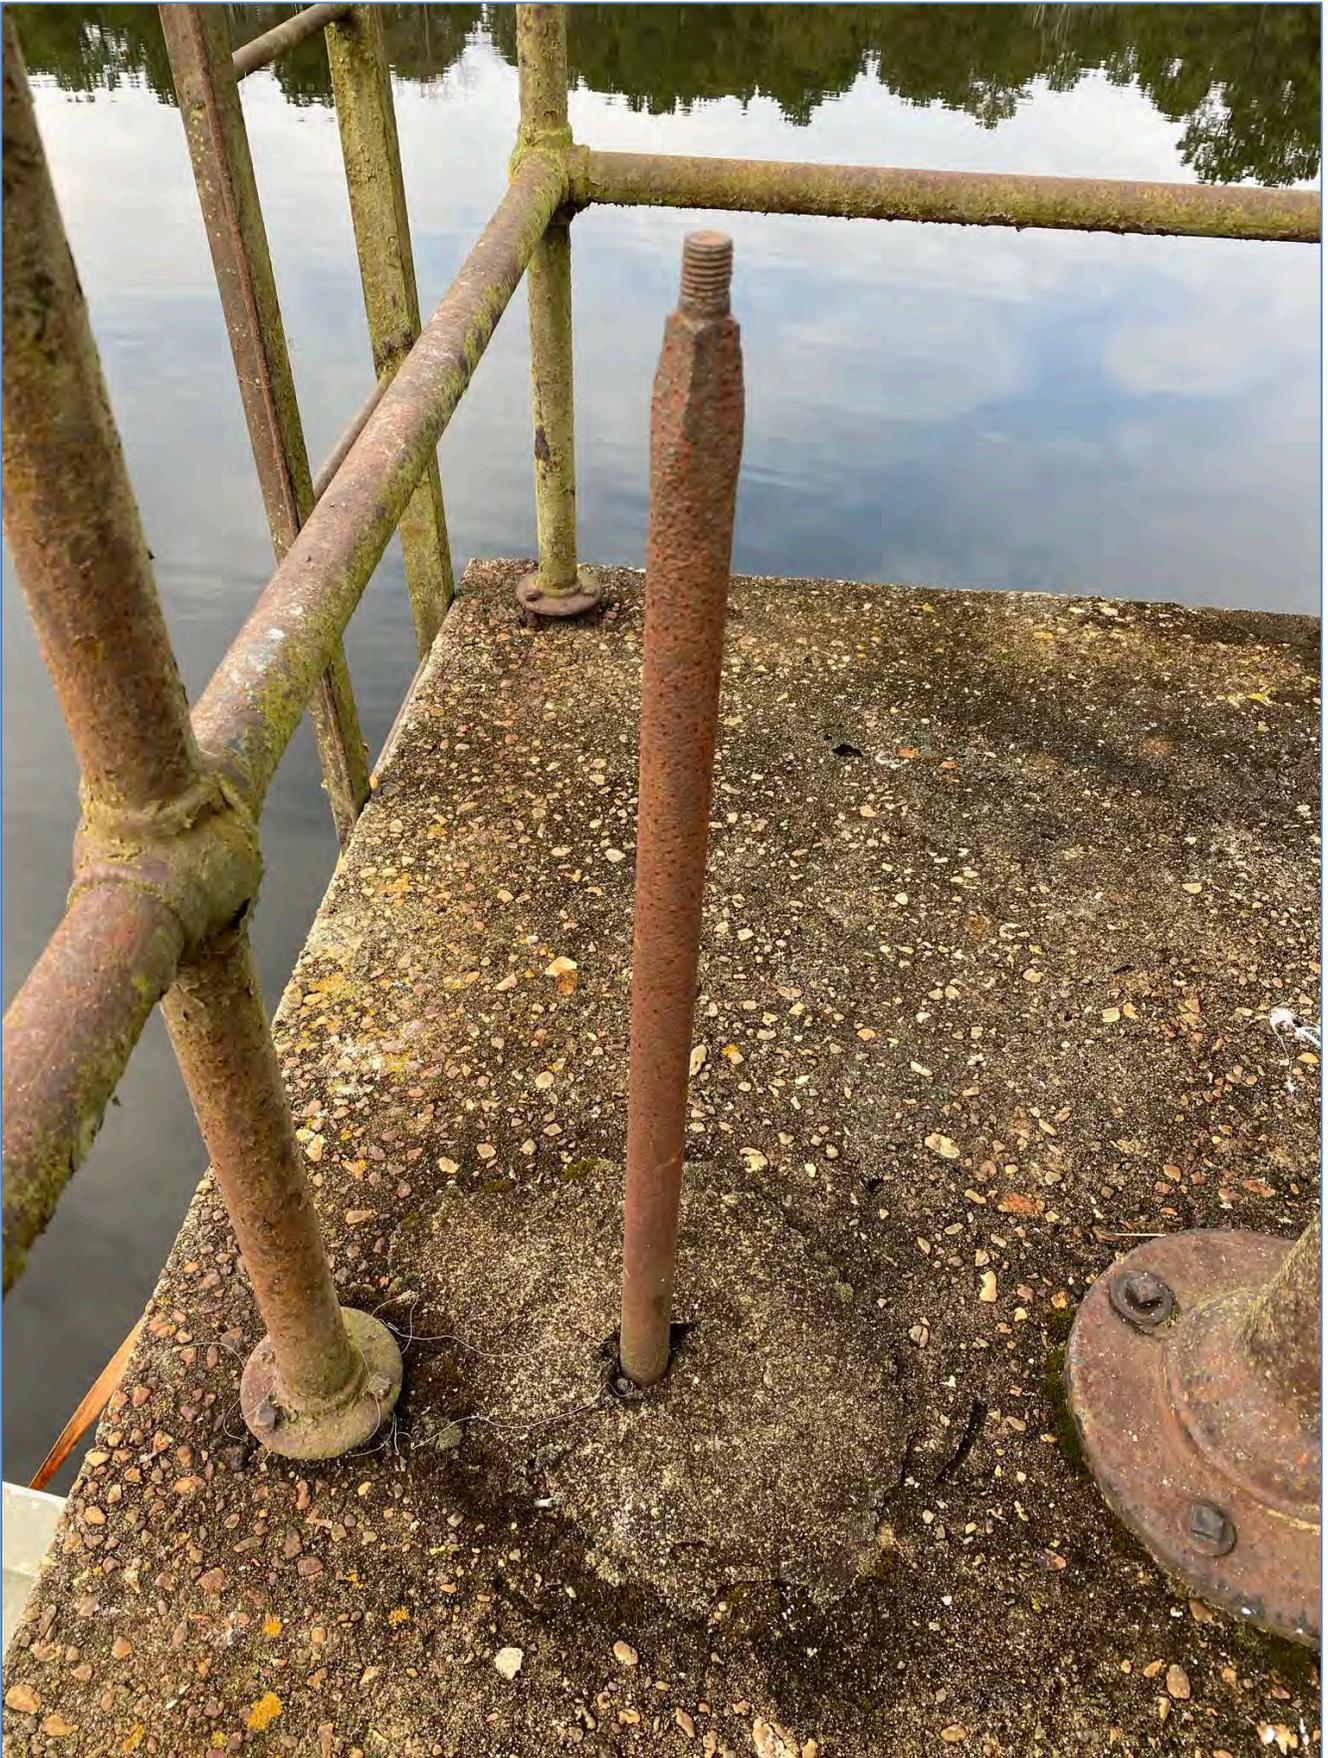
The exterior valve was full open. It is a non-rising stem sluice gate. A metal stem was noted sticking up through the hole in the operating floor. The top of the stem was threaded, likely to accommodate a handwheel. The stem travels down to the sluice gate and was heavily deteriorated.

Figure 32 - Outer Valve Stem sticking up through hole in concrete tower

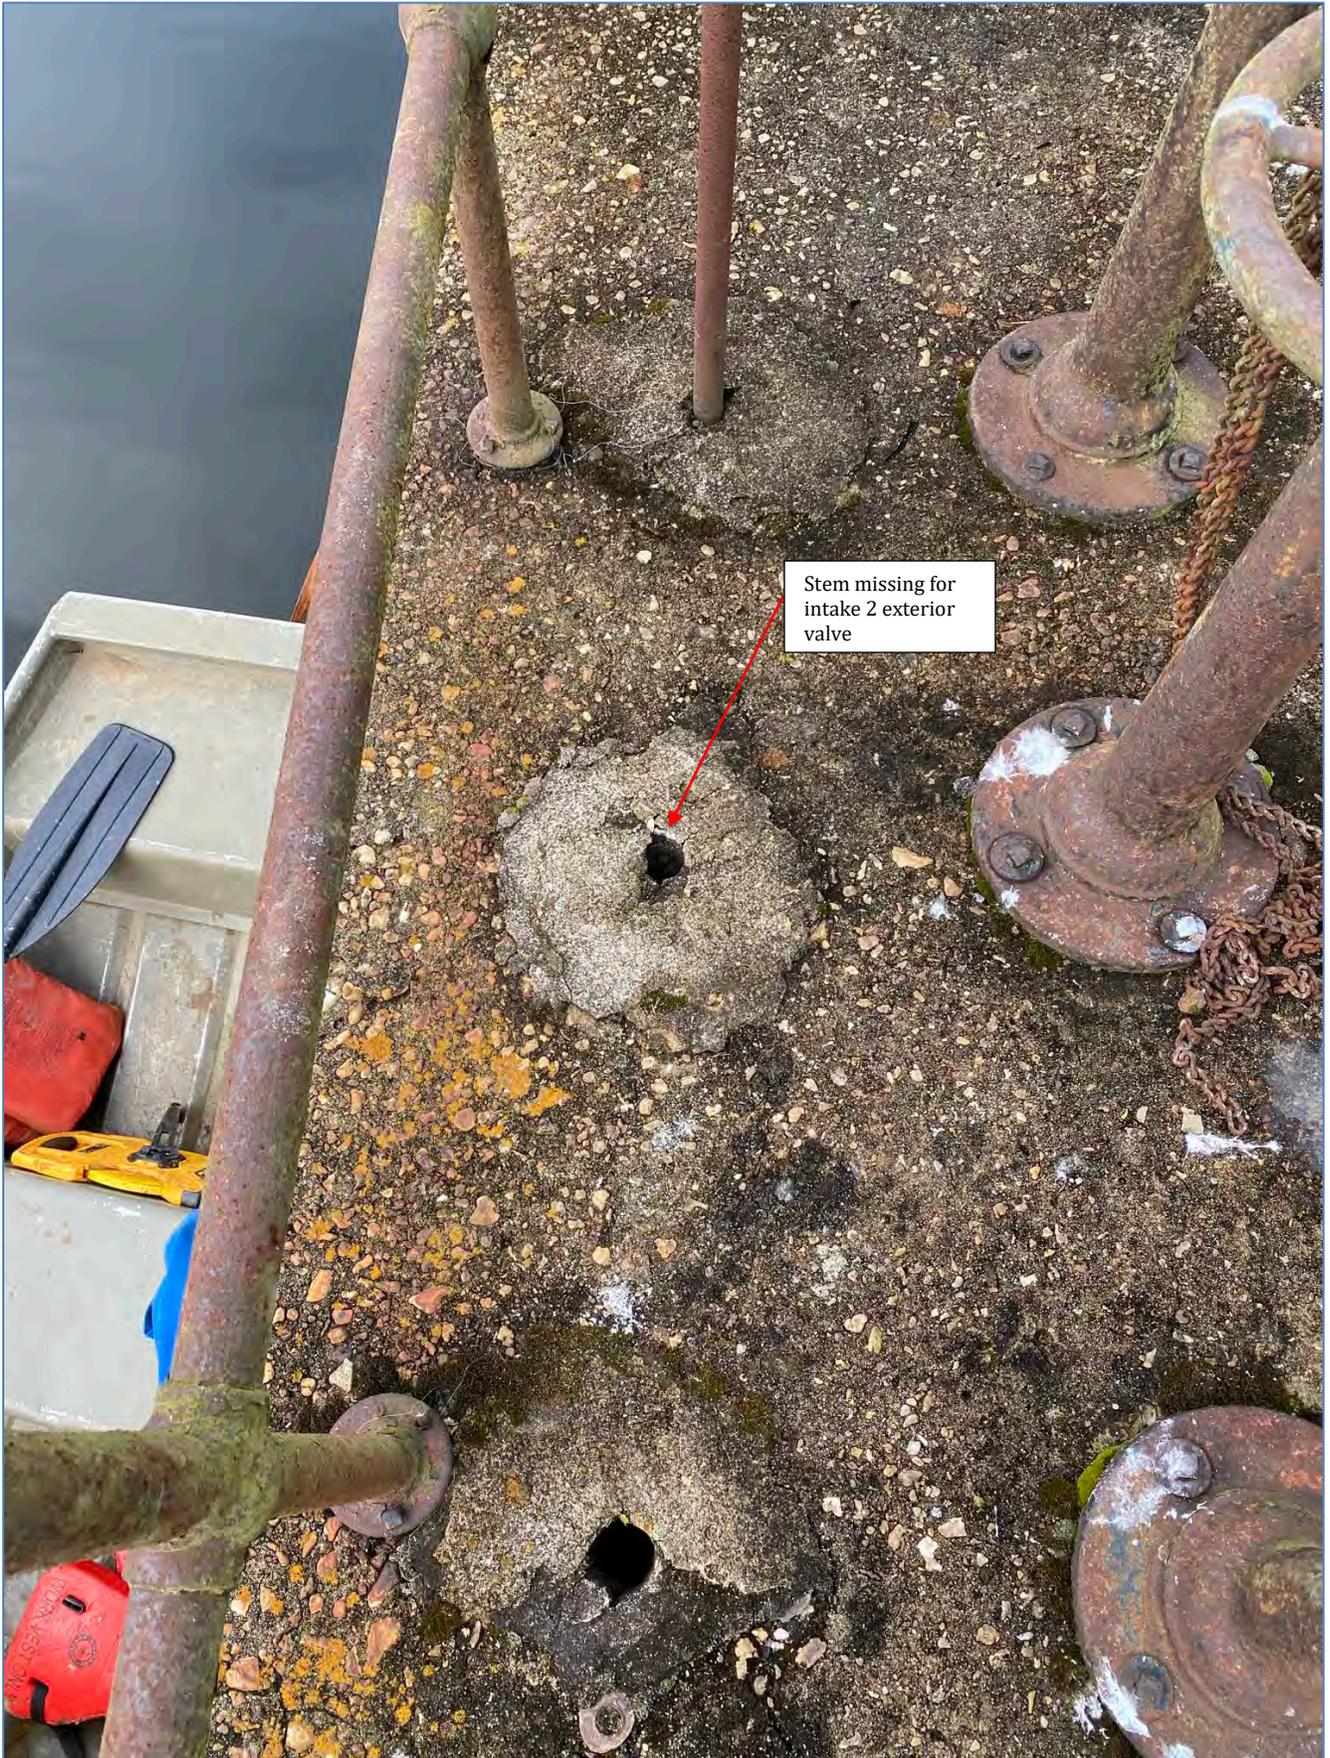
Figure 41 - Exterior Valve Hole in Operating Floor, stem missing

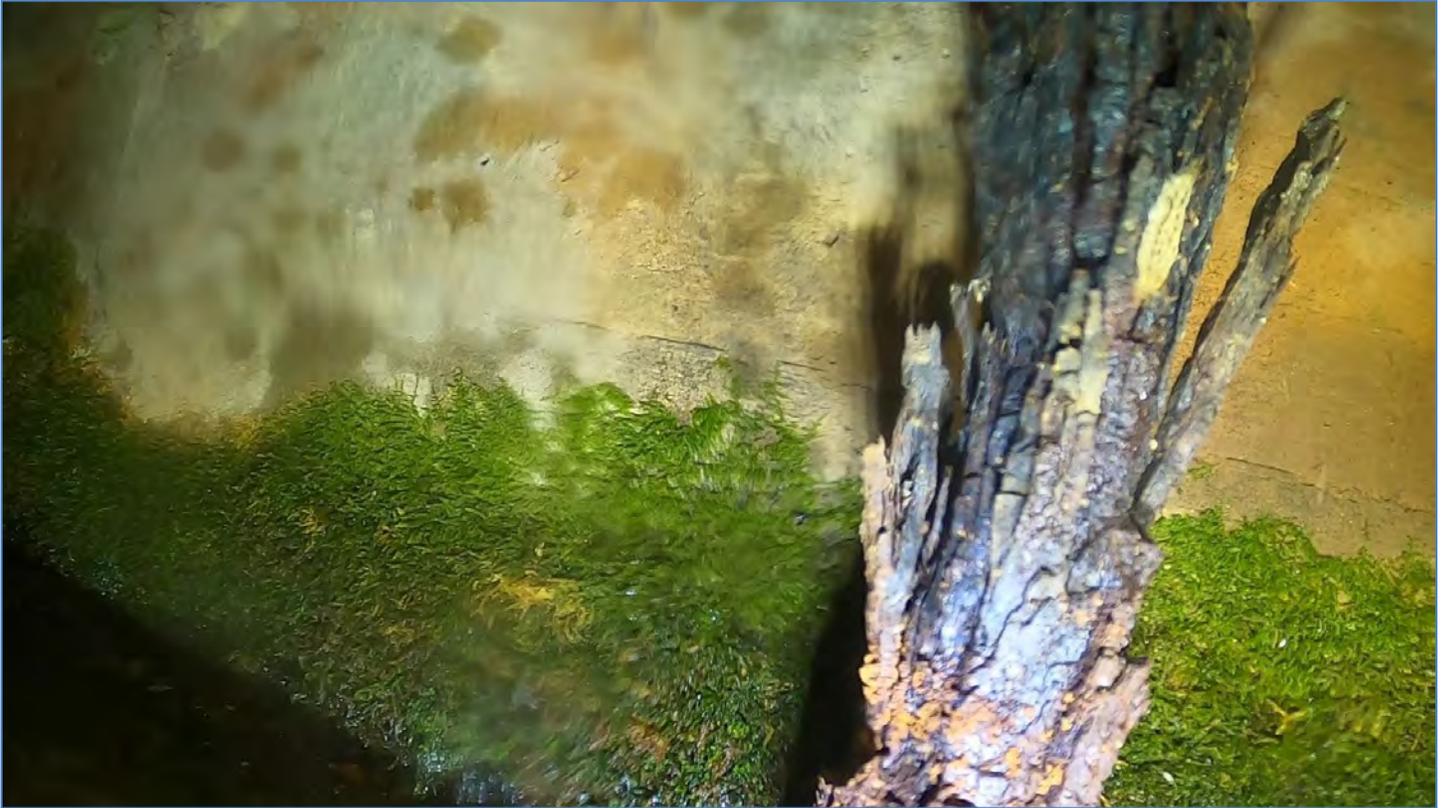
| Structure: | Condition: | Notes: |
|--|---|--|
| 16" Intake No. 2 | Critical | The outer valve is shut, and the inner valve is $\frac{1}{2}$ open. Heavy corrosion throughout, especially at the water line. The operator appears seized up. |

Figure 44 - Stem for interior valve 2 heavily corroded.

The valves are old, showing significant signs of corrosion, and several components have failed. The valves and components are not salvageable. The future purpose of the tower should be determined. At which point, a repair plan can be implemented. If the goal is to have an operational low level drain system, then several of the valves can be removed or blanked off, and a new low level drain valve installed in the tower. The inlet to the water supply line on the outside of the tower will need to have the sediment diver-displaced.

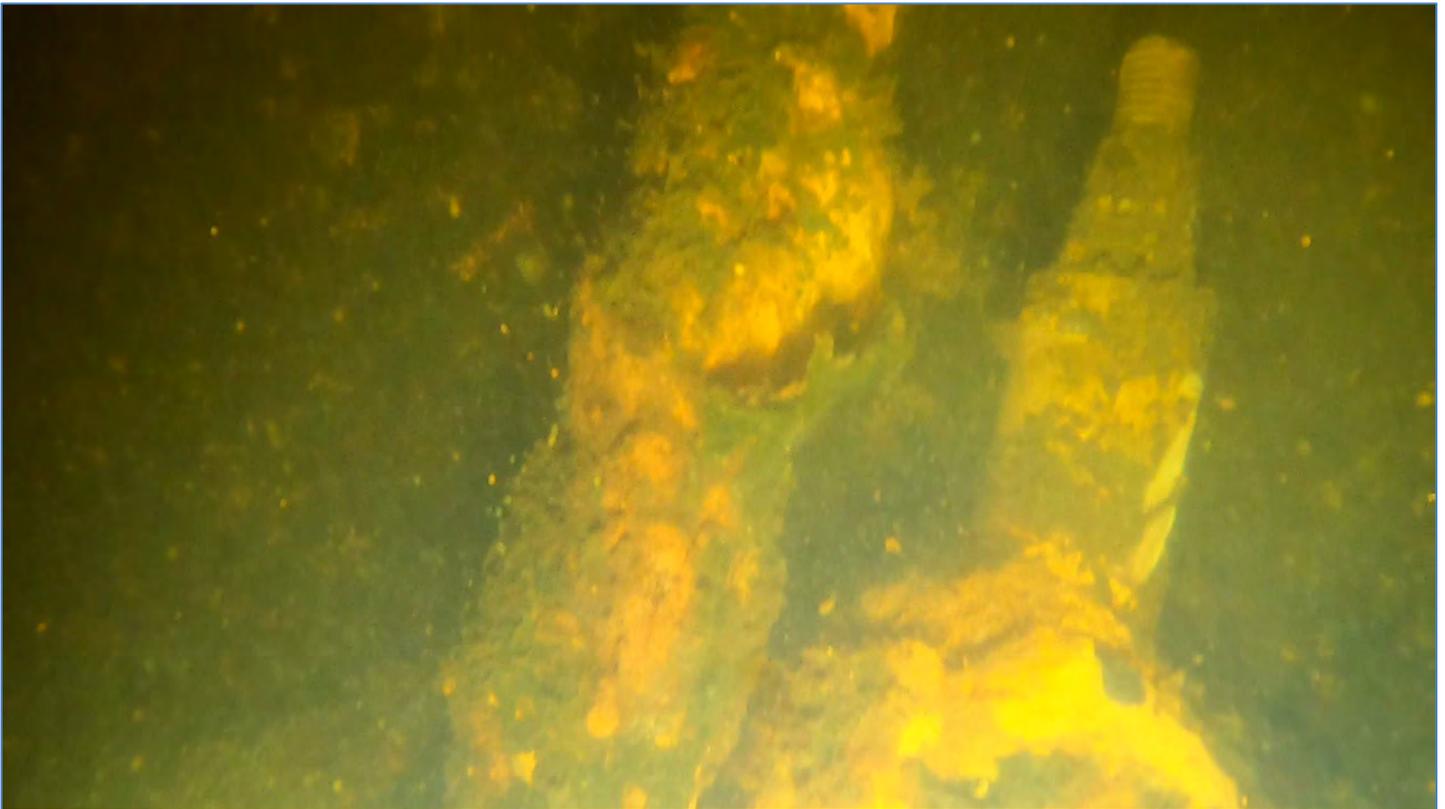
The exterior valve appeared to be shut. The diver could not reach the gate slide on the exterior face due to the trash rack but looking upstream from inside the tower the valve appears closed. It is a non-rising stem sluice gate. The top portion of the metal stem was missing and not observed through the hole in the operating floor. A portion of the stem was visible below the water surface and is heavily deteriorated. A section of the stem was also found broken off and laying beside the valve.

Figure 45 - Outer Valve, stem disconnected and leaning beside valve

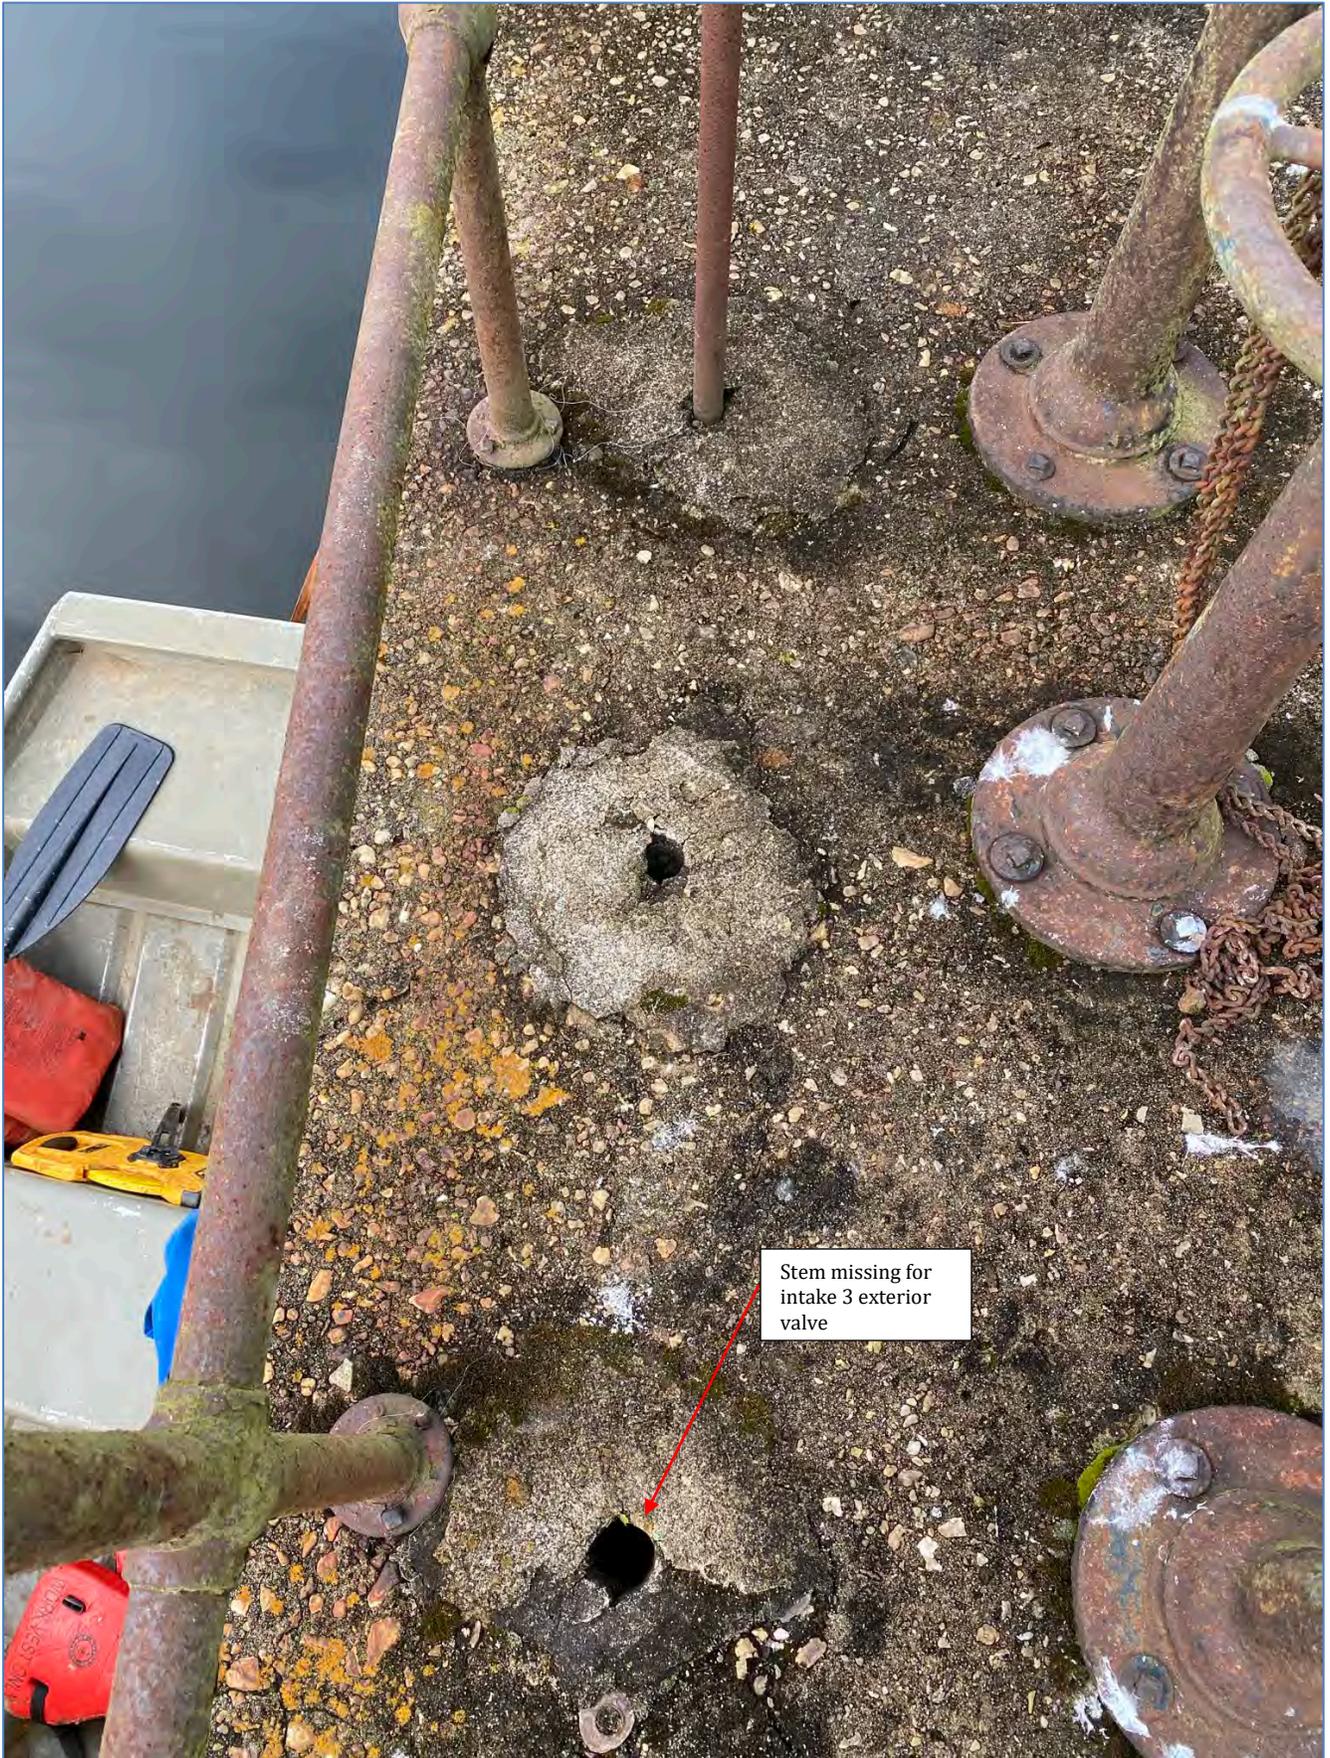
Stem missing for intake 3 exterior valve

Figure 47 - Intake 3

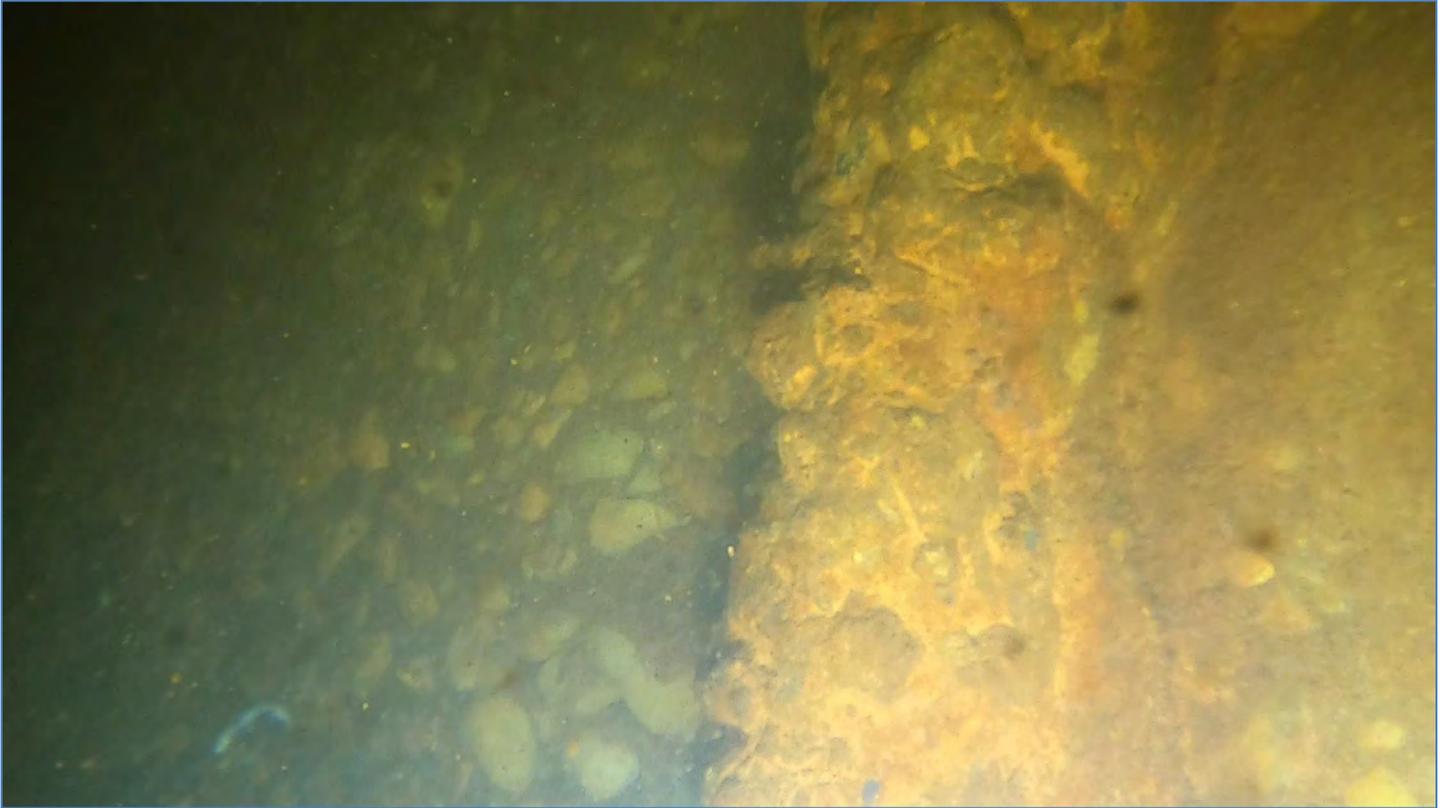
| Structure: | Condition: | Notes: |
|--|---|--|
| 16" Intake No. 3 | Critical | Both the inner and outer valves are shut. The inlet is 12" above the sediment bottom. Heavy corrosion throughout, especially at the water line. The stem is bent. The operator appears seized up. |

Interior Wall Face to stem centerline = Approx. 6", however bent in several areas.

Figure 48 - Interior Valve Stem bent towards upstream tower face

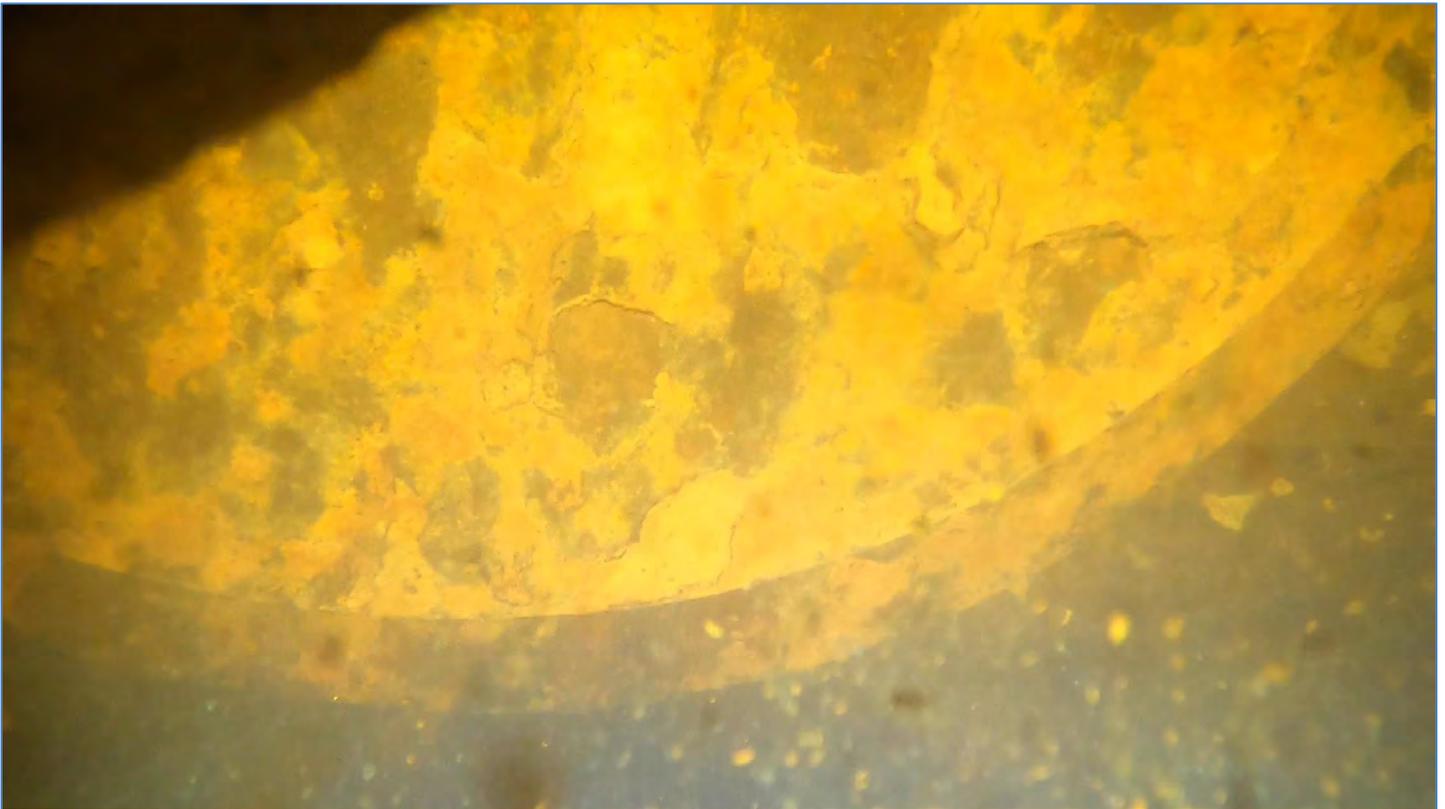
Figure 51 - Exterior Valve 3, Gate slide closed
