**Southern Pines Waterworks Dam Siphon
Town of Southern Pines, NC**

ADDENDUM NO. 3

Inspection Report

Southern Pines Waterworks Dam - Intake Tower
Southern Pines, North Carolina

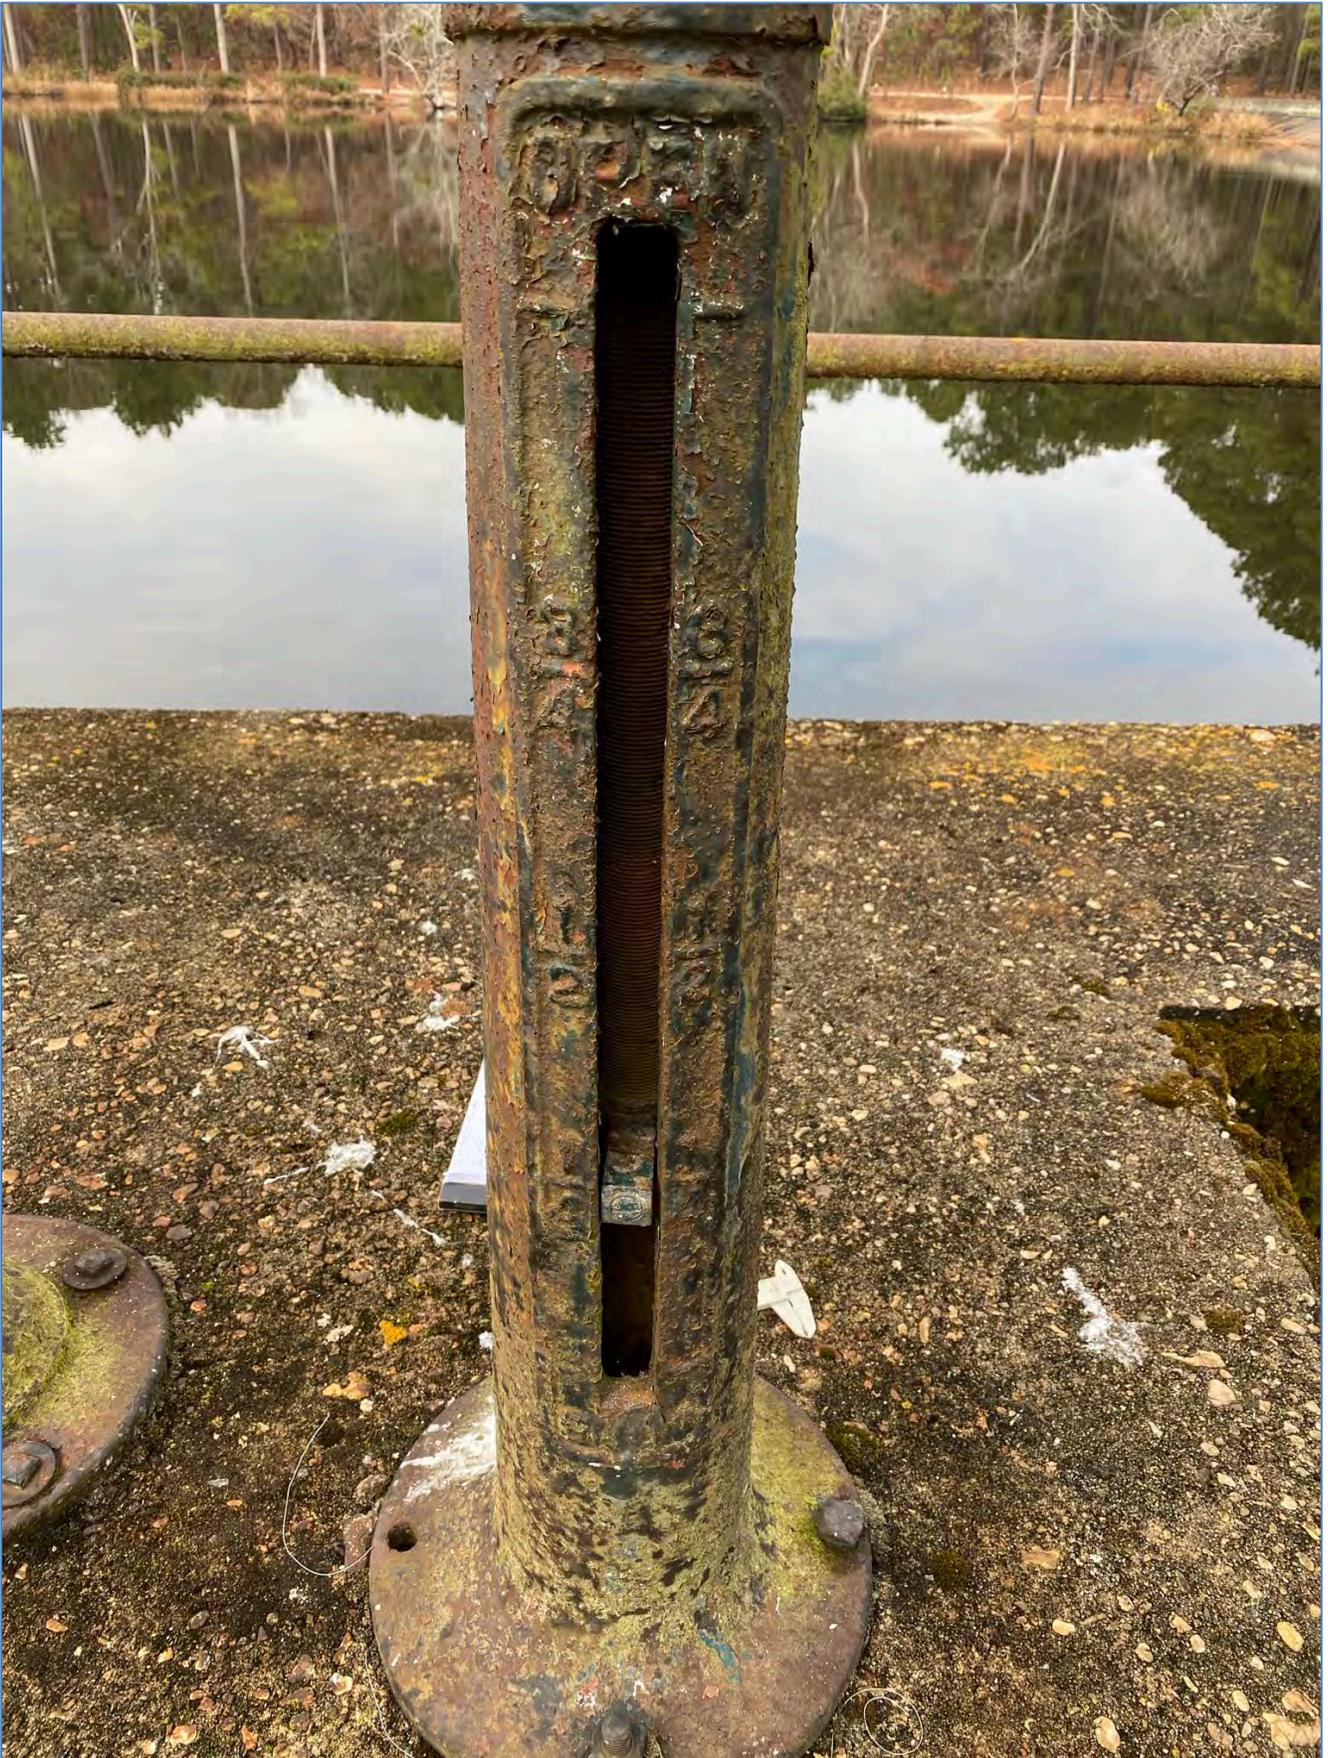
The position indicator on the 24" low level drain valve showed the valve to be $\frac{1}{4}$ open. This could not be confirmed by the diver due to the bonneted valve system and the fact the inlet is buried in 3' of sediment. It is unclear if the 24" water supply line running through the dam is pressurized. The downstream plunge pool should be pumped out and a crawler camera system inserted to evaluate the pipe through the dam. This will help determine the pipe's exact layout and condition.

Figure 54 - Gate 4 Operator Pedestal, note ¼ open position

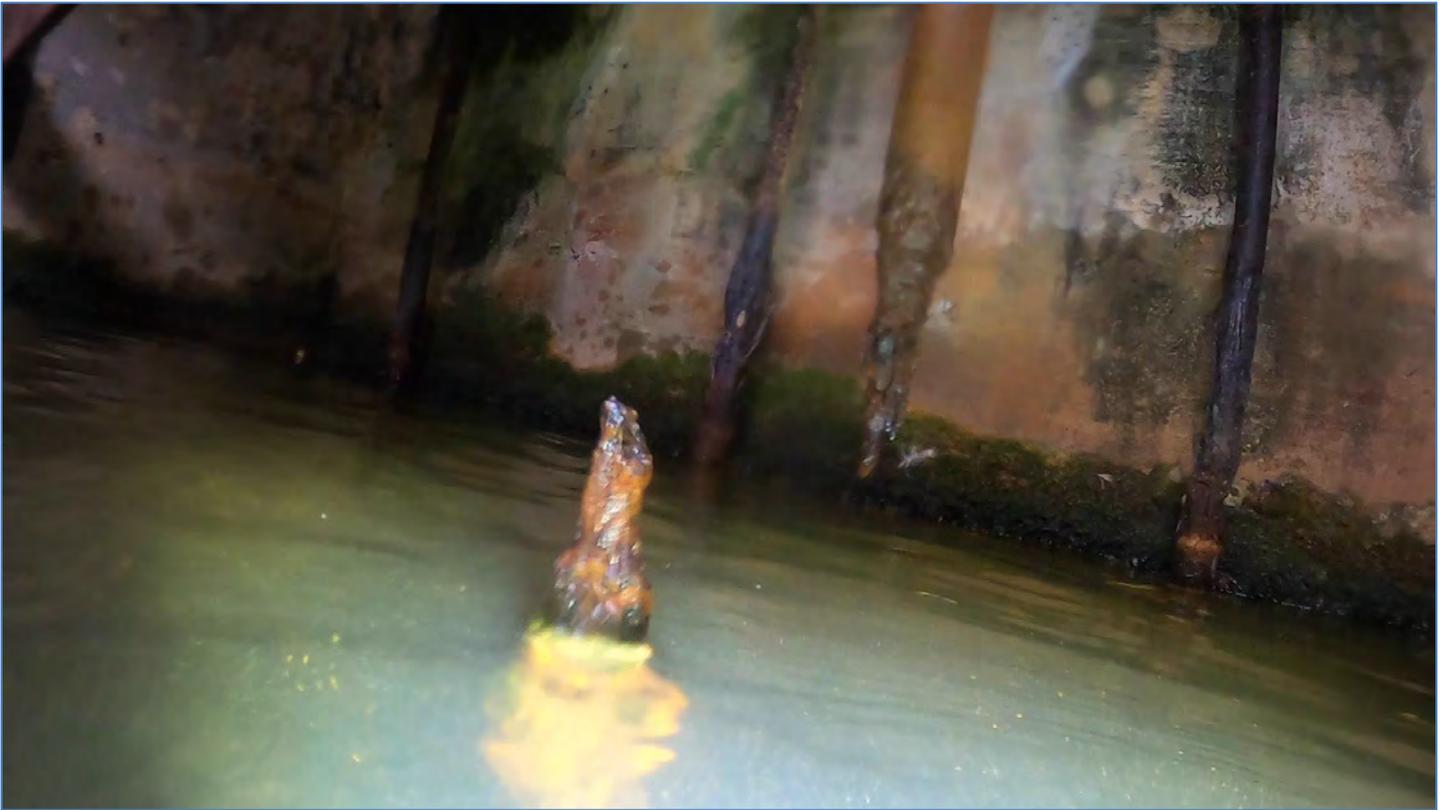
| Structure: | Condition: | Notes: |
|--|---|--|
| Valve No. 4 – 24" Bottom Drain | Critical | The low-level drain inlet is buried in approximately 3' of sediment. The stem is broken at the waterline. The operator appears to be seized up. The pedestal position indicates the valve is open $\frac{1}{4}$. This could not be confirmed by the diver due to the bonneted design. |

The sluice was not operated due to the sediment levels around the tower and the fact the stem was broken.

Figure 55 - Gate 4 Stem Broken at waterline

The valves are old, showing significant signs of corrosion, and several components have failed. The valves and components are not salvageable. The future purpose of the tower should be determined. At which point, a repair plan can be implemented. If the goal is to have an operational low level drain system, then several of the valves can be removed or blanked off, and a new low level drain valve installed in the tower. The inlet to the water supply line on the outside of the tower will need to have the sediment diver-displaced.

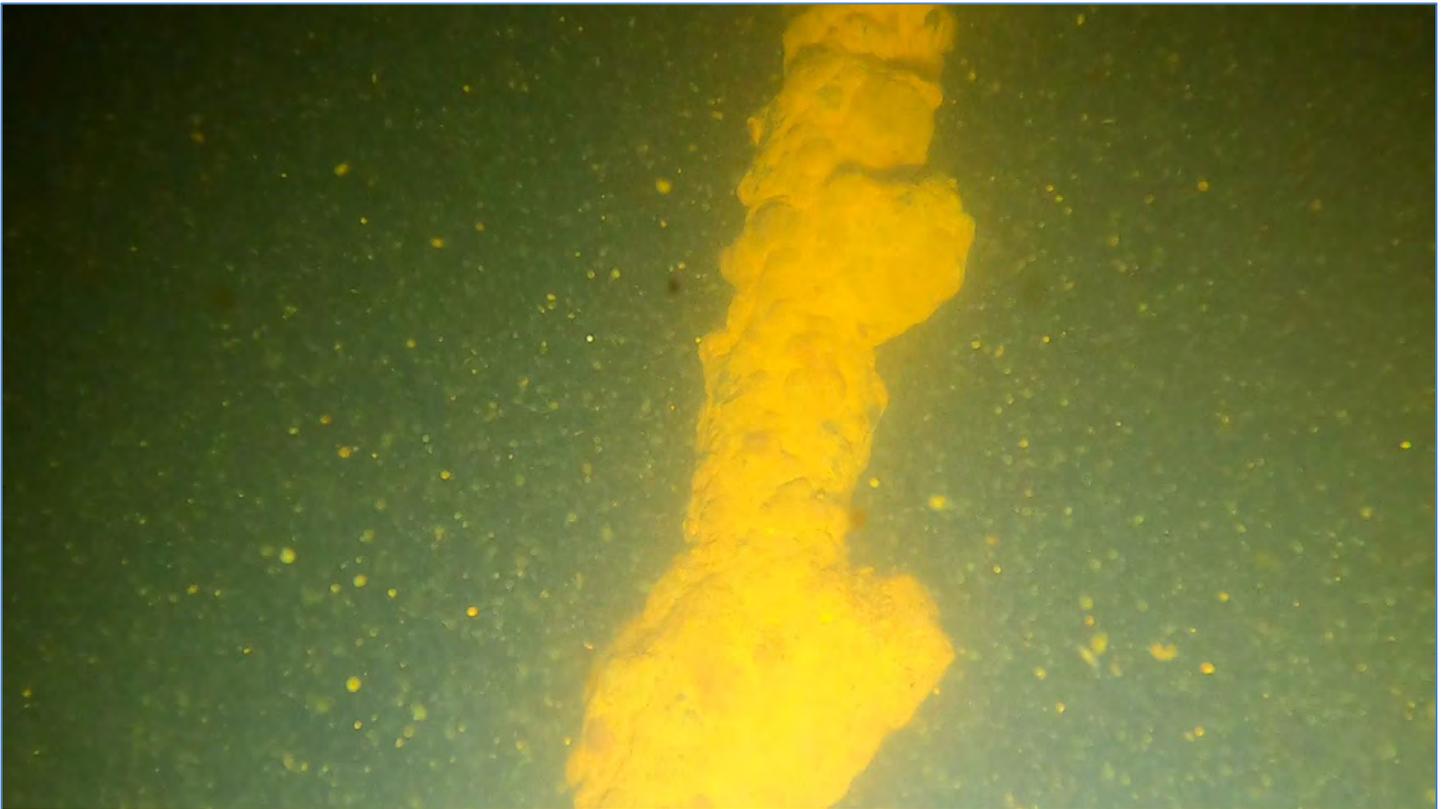
Figure 56 - Gate 4 stem underwater, note accumulation

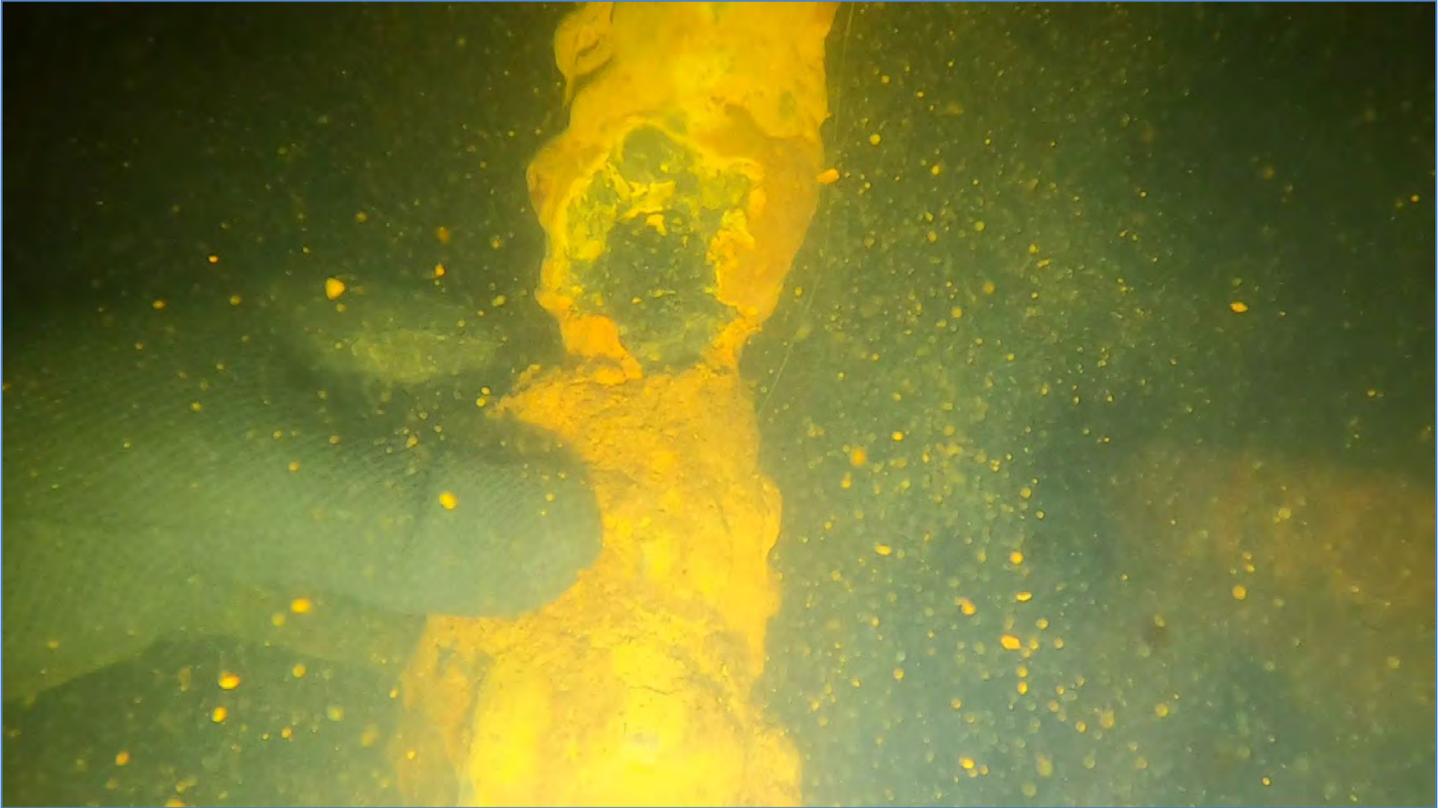
| Structure: | Condition: | Notes: |
|--|---|--|
| Valve No. 5 – 24" Water Supply Control | Poor | Unique stopper style valve with a 90-degree stem transition. Heavy deterioration but no breakages observed. The operator is seized up. Pedestal position indicator shows the valve to be $\frac{1}{4}$ open however the diver confirmed the valve was closed. |

Figure 67 - Gate 5 stem several feet above gate frame, note deterioration

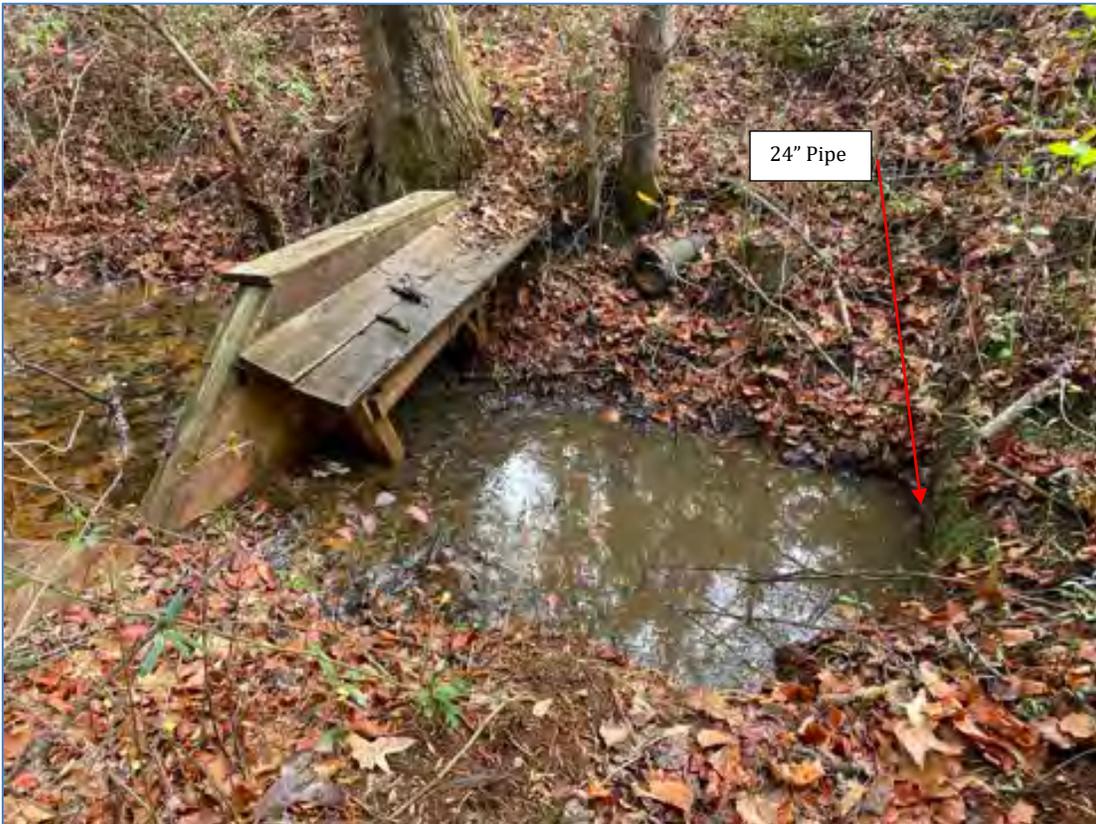
| Structure: | Condition: | Notes: |
|--|---|--|
| Outfall & Plunge Pool | Fair | The discharge end of the 24" supply line is underwater due to sediment build-up downstream. The line was open at least 20' upstream. No water flow observed. |

Figure 74 - Discharge end of 24" Water Line

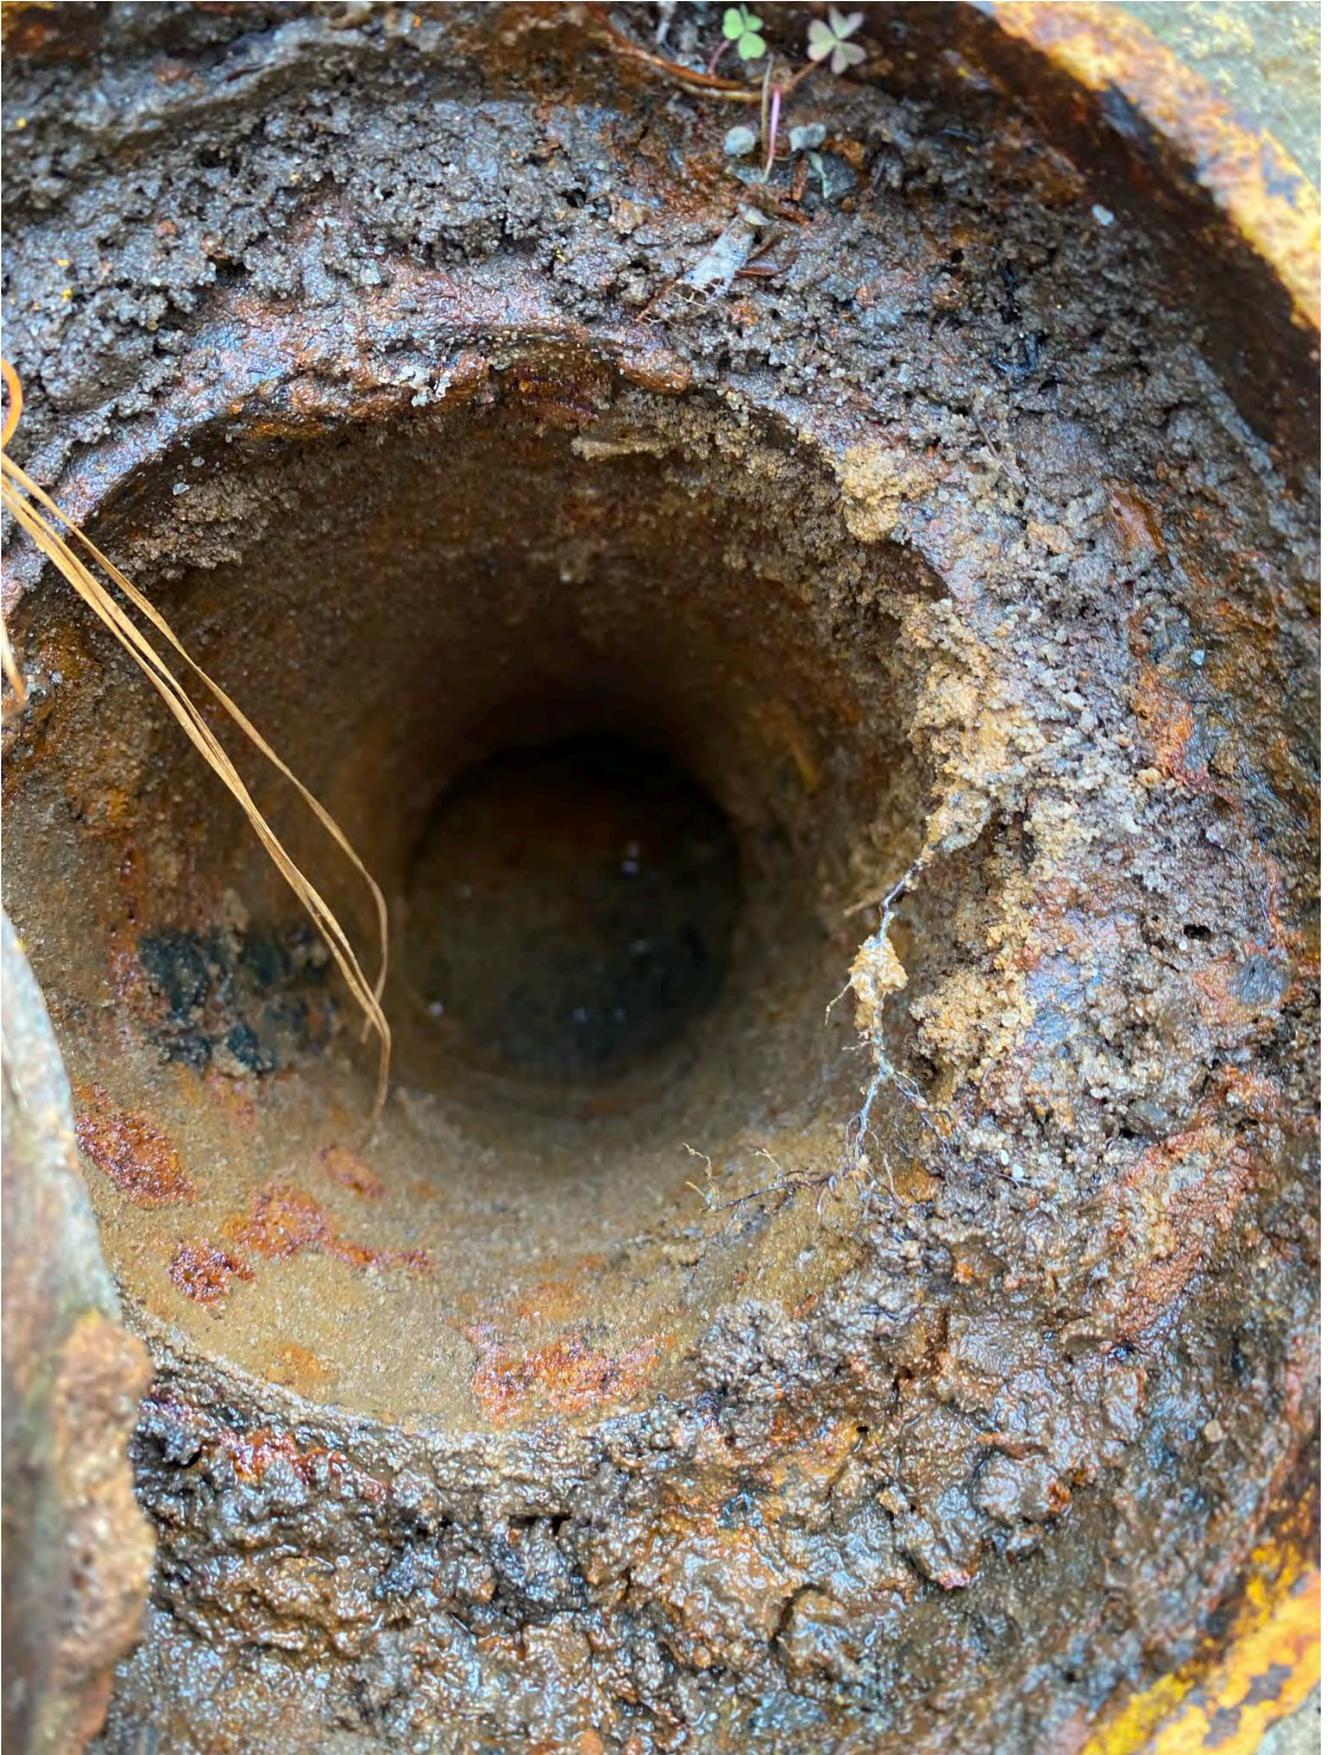
A valve box was observed roughly 15' upstream of the discharge end of the pipe. The valve box was offset from the water line by several feet. It is unclear if this is due to the valve box leaning or because of an offset valve configuration, such as a butterfly valve. No operating nut was observed down into the valve box.

The inspector stuck a 20' long pole upstream into the 24" pipe and no obstructions were encountered. The pole extended past the location of the valve box indicating this box is either not associated with the 24" line or the valve is open.

Figure 77 - Looking down into valve box
