**Southern Pines Waterworks Dam Siphon
Town of Southern Pines, NC**

ADDENDUM NO. 3

Inspection Report

Southern Pines Waterworks Dam - Intake Tower
Southern Pines, North Carolina

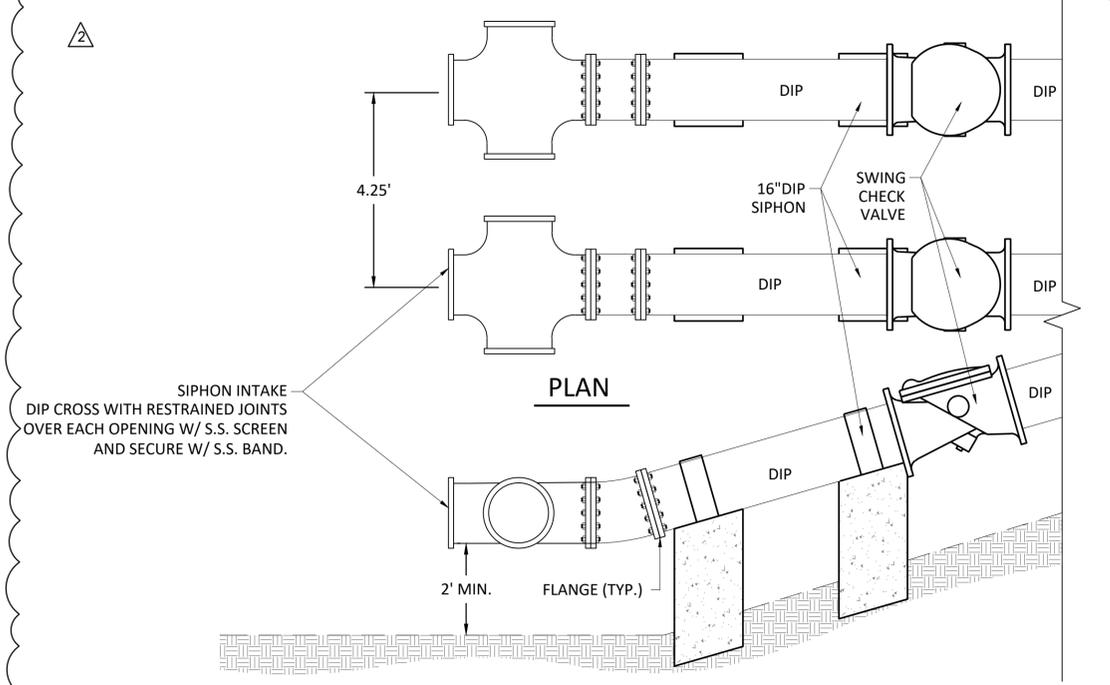
4 SIPHON INTAKE
1" = 2"

7. **Question:** Detail 4 on Drawing C-3 shows a dark rectangular shape near the end of the intake section, just before the perforated portion of the PVC pipe begins. This appears to indicate a pipe strap with a foundation beneath it; however, the elevation view in this detail does not clearly show a foundation, and a corresponding foundation is not shown in the profile view on Drawing C-2.

Please clarify what this element represents and confirm whether a foundation or support is required at this location, or if this is a drafting error.

Response: The siphon intake has been replaced with a DIP cross with flanged connections. Refer to Sheet C-3 attached to this addendum.

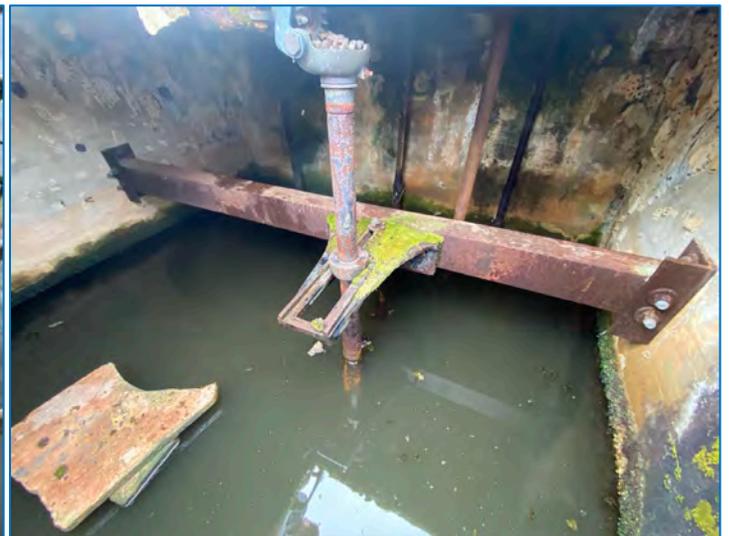
Figure 13 – Tower Interior (debris in lower left corner)

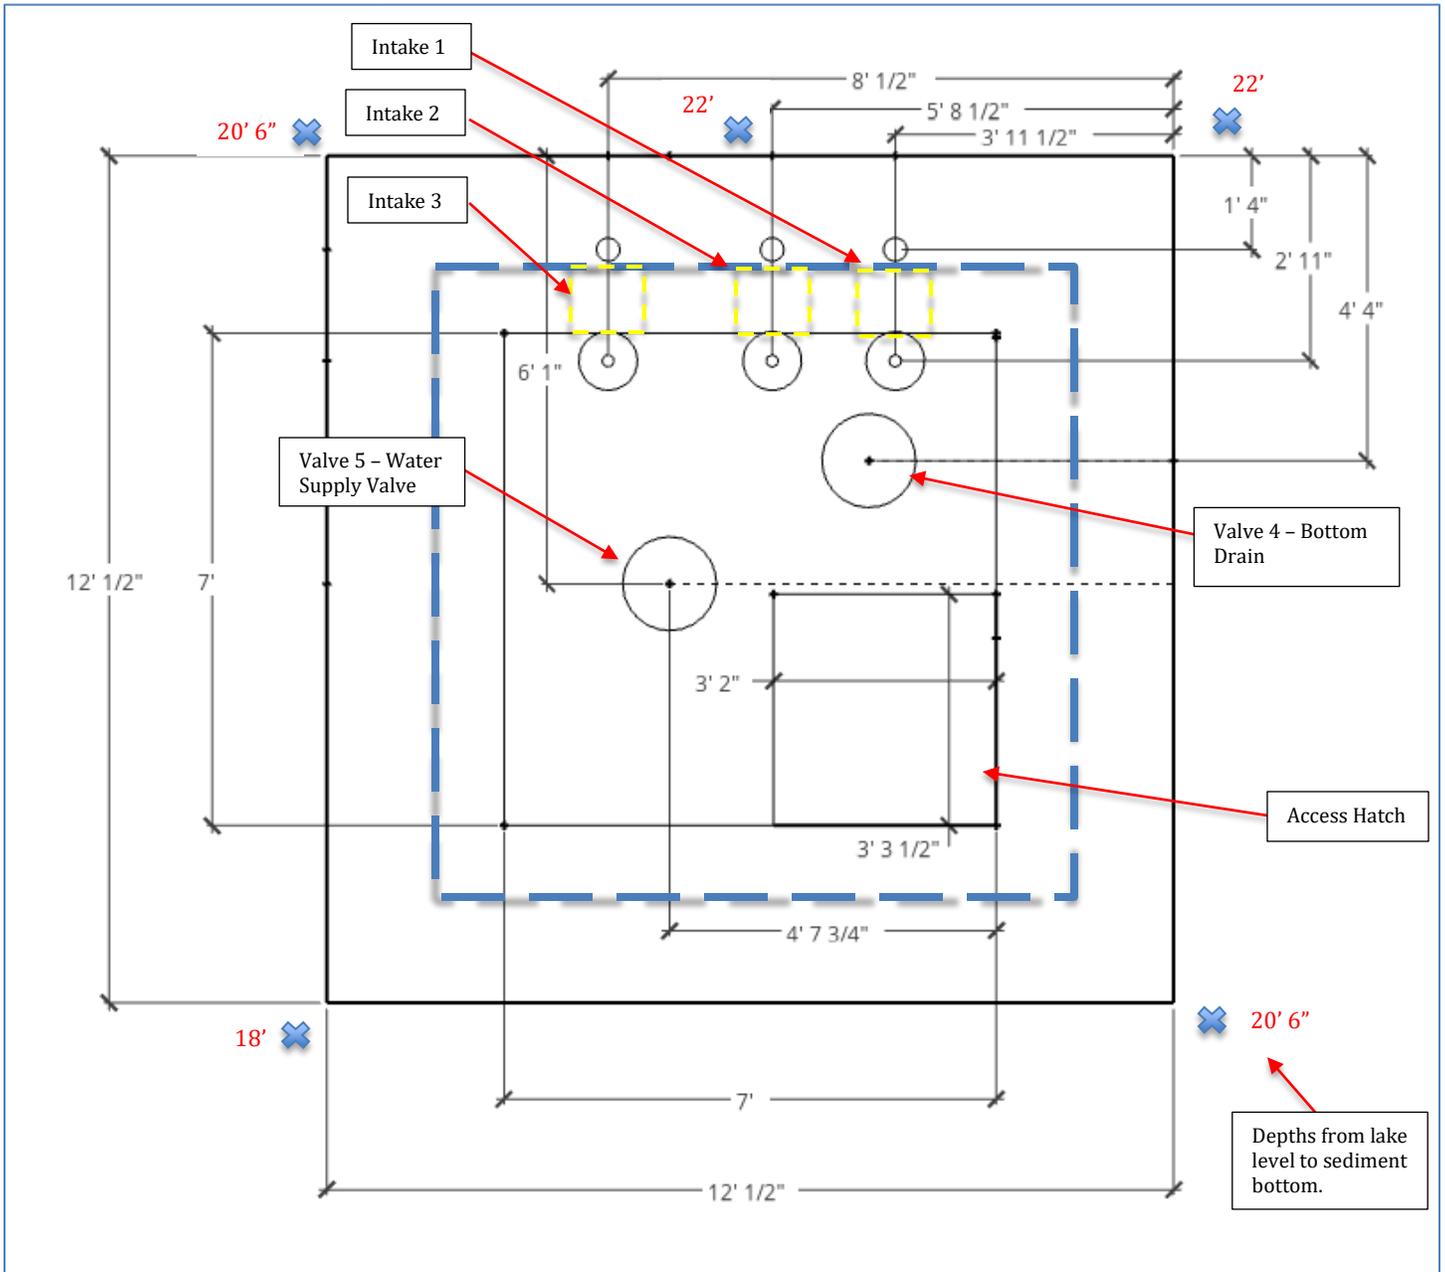
Figure 15 - Top of Tower (operating floor) layout

Sediment has collected around the riser tower. Depth measurements were recorded and shown on Figure 15. The depth along the upstream/lake side tower face was approximately 22'. The sediment was approximately 12" below intake 3, but 3' above the low-level bottom drain invert.

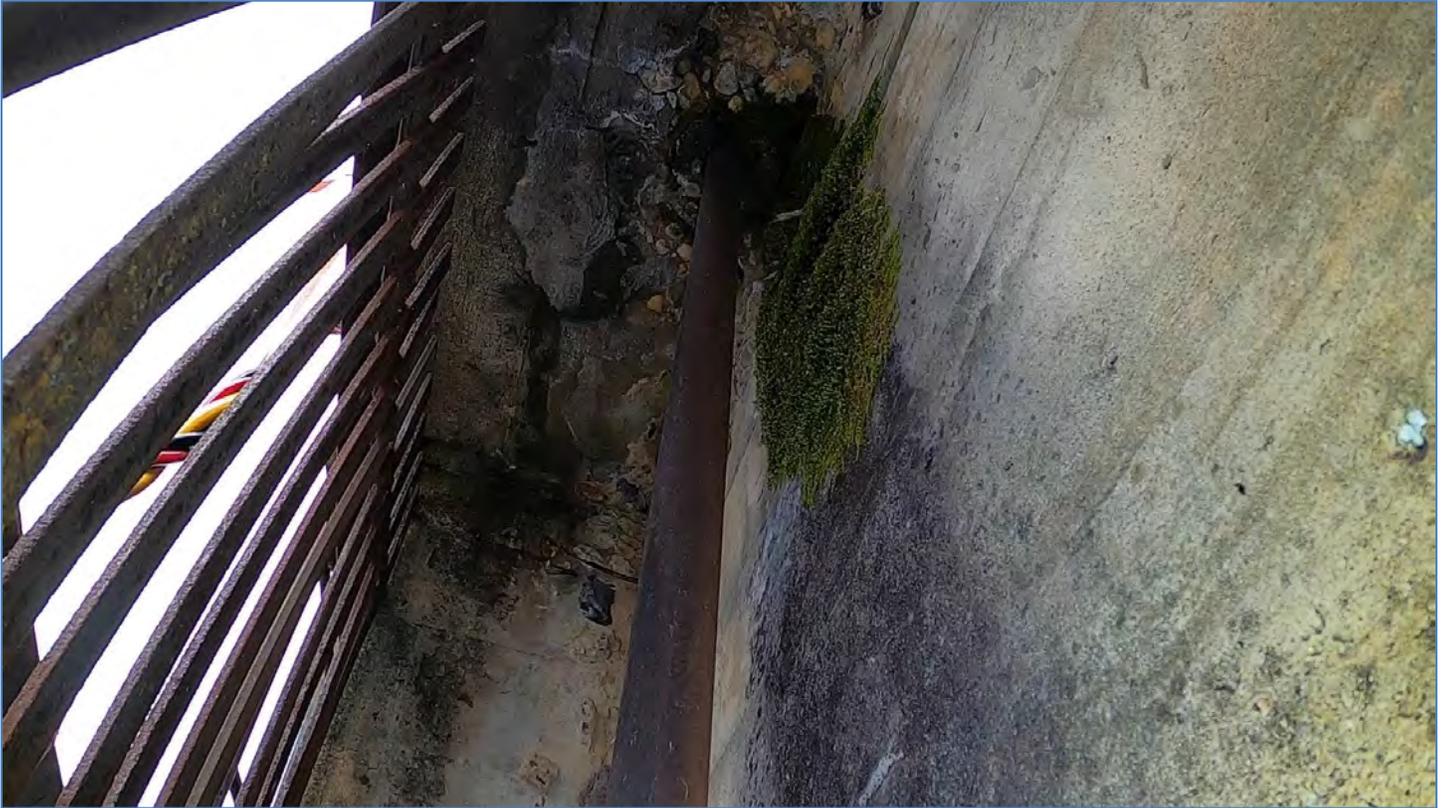
Figure 33 - View of stem coming through underside of tower

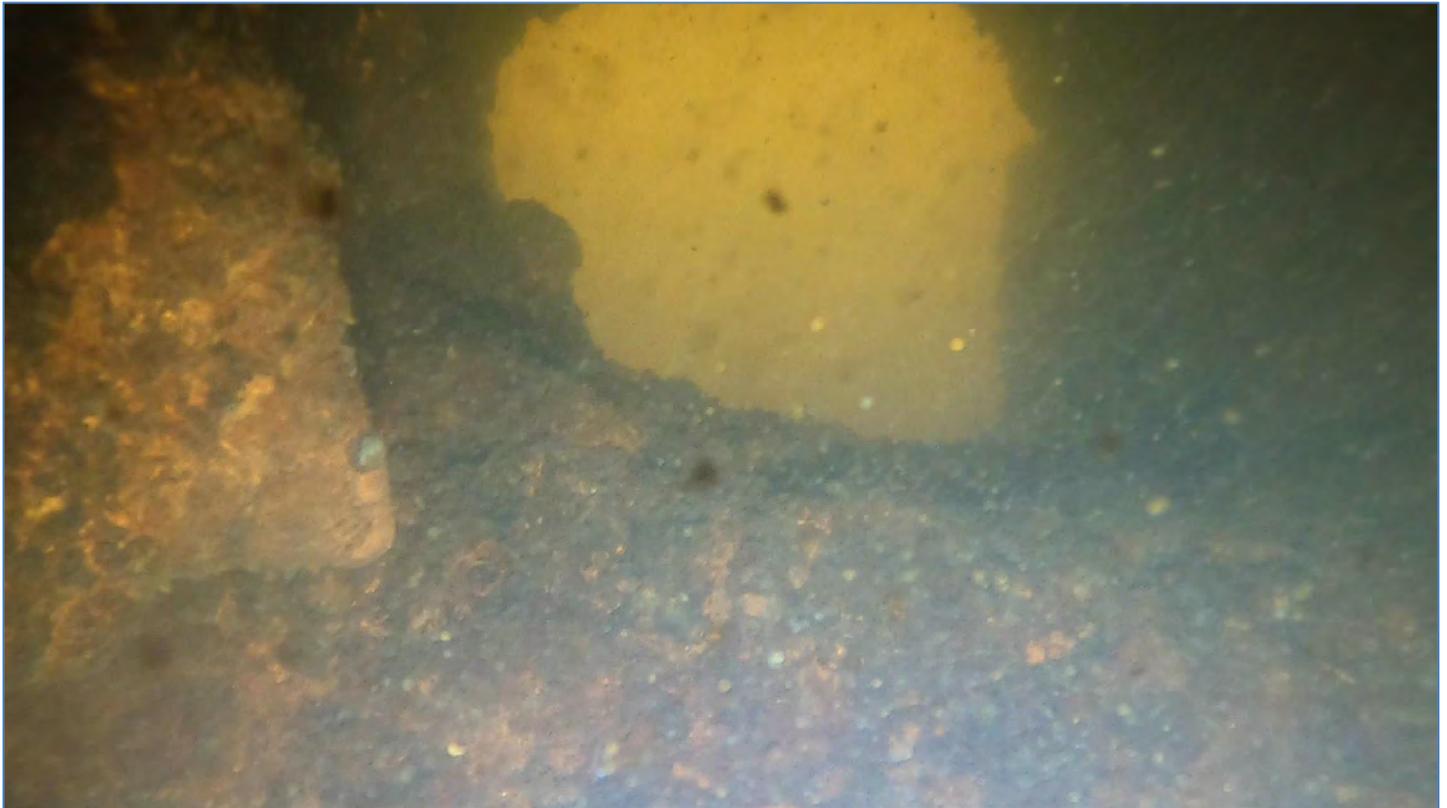
Figure 38 - Bottom of Interior Sluice Gate 1 looking upstream through intake

The exterior valve appeared to be shut. The diver could not reach the gate slide on the exterior face due to the trash rack but looking upstream from inside the tower the valve appears closed. It is a non-rising stem sluice gate. The top portion of the metal stem was missing and not observed through the hole in the operating floor. A portion of the stem was visible below the water surface and is heavily deteriorated. A section of the stem was also found broken off and laying beside the valve.

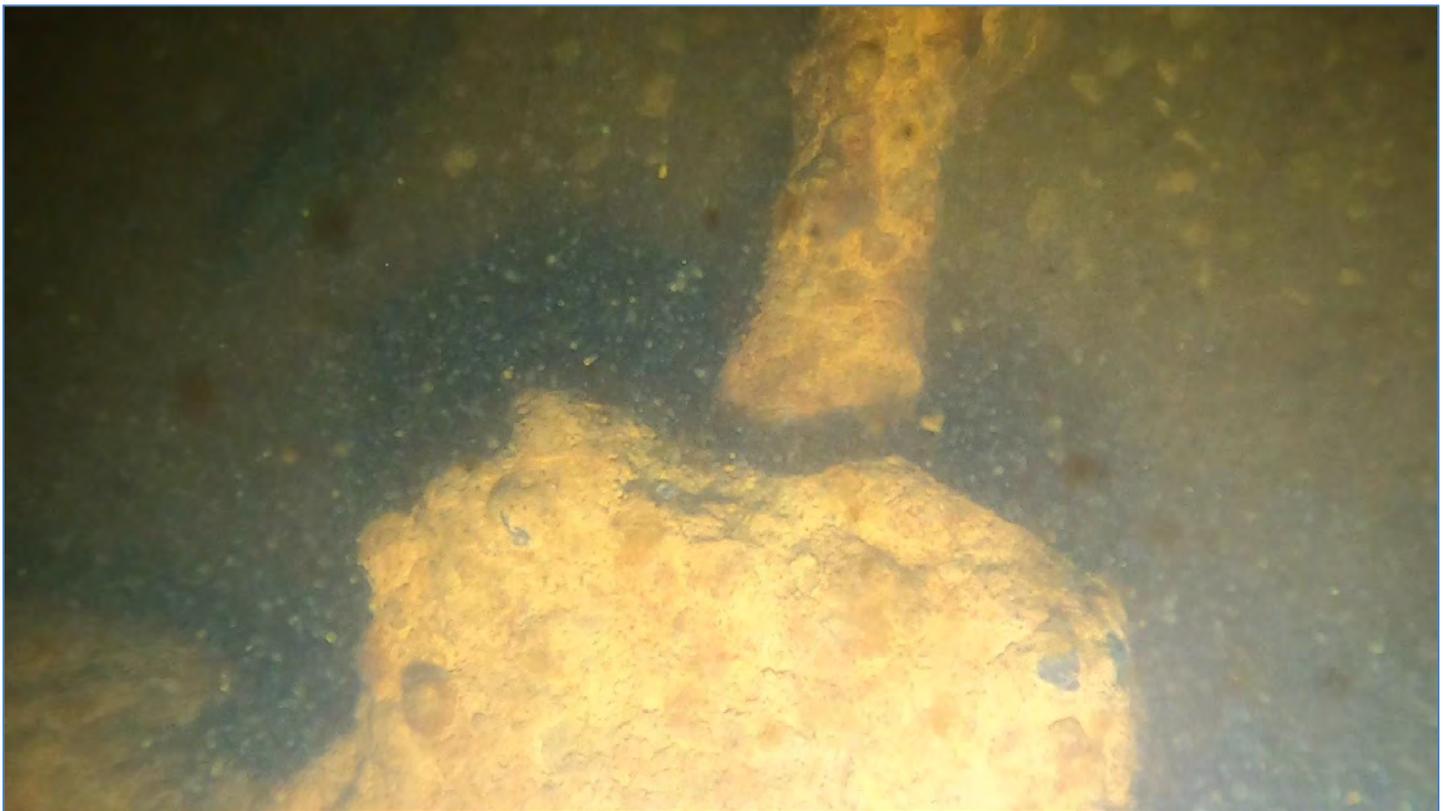
Figure 43 - Stem connection into interior valve 2

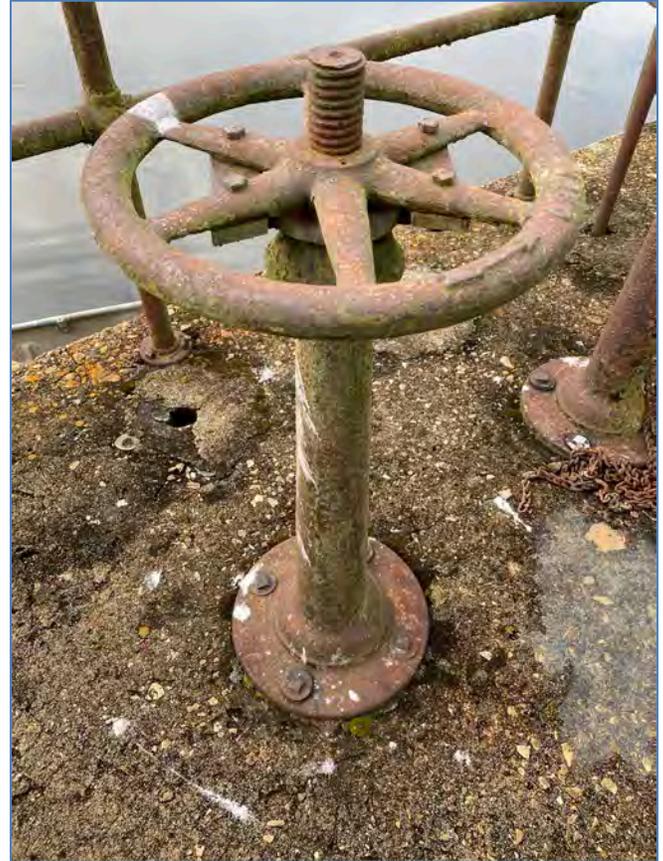
Figure 46 - Interior Operator on Intake 3

Interior Wall Face to stem centerline = Approx. 6", however bent in several areas.

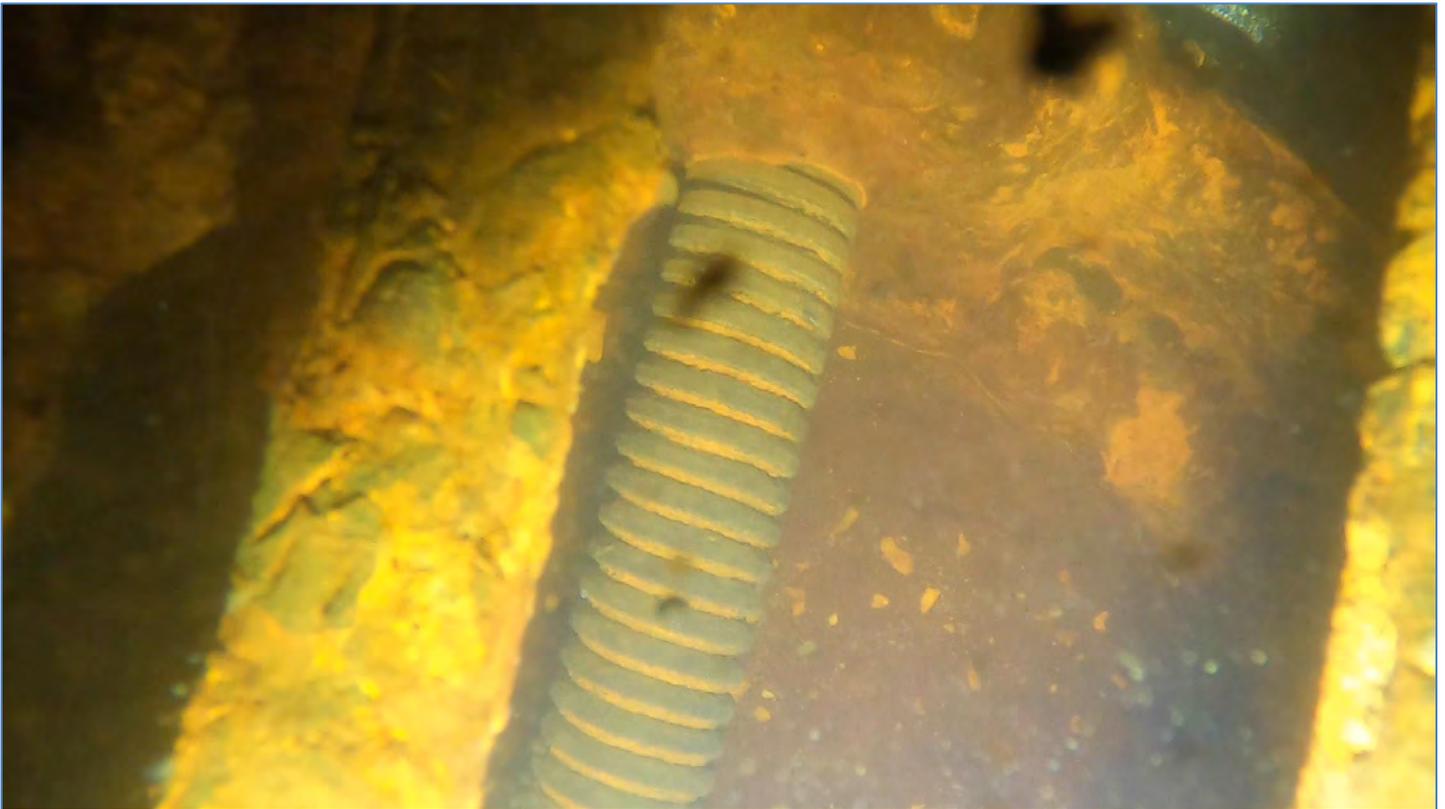
Figure 49 - Exterior Valve 3 threaded stem connection at valve

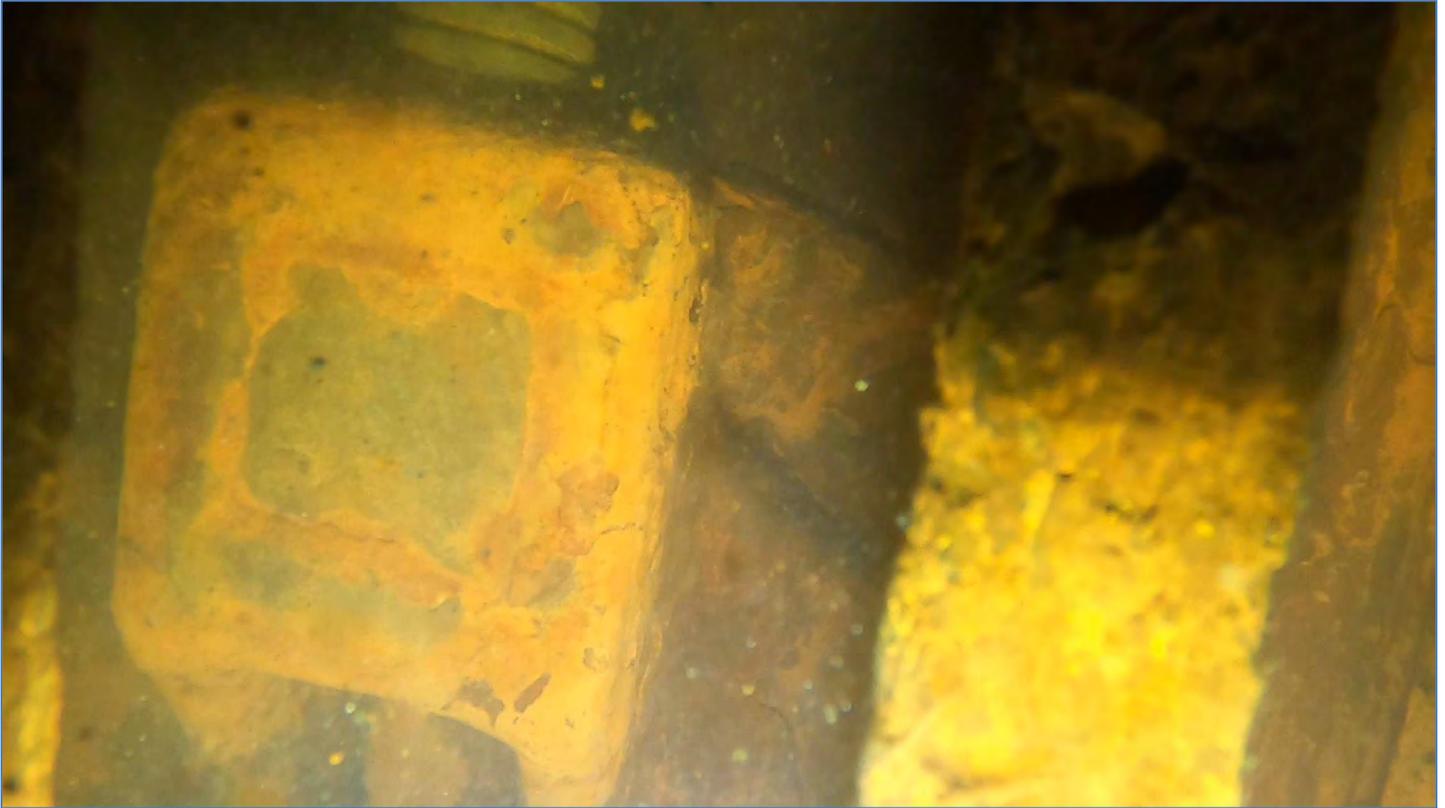
Figure 50 - Exterior Valve 3 thrust nut connection

The exterior valve was shut as well. It is a non-rising stem sluice gate. The top portion of the metal stem was missing and not observed through the hole in the operating floor. The valve body is heavily deteriorated, however its condition improved slightly at deeper depths. The invert is roughly 12" above the lake bottom sediment.

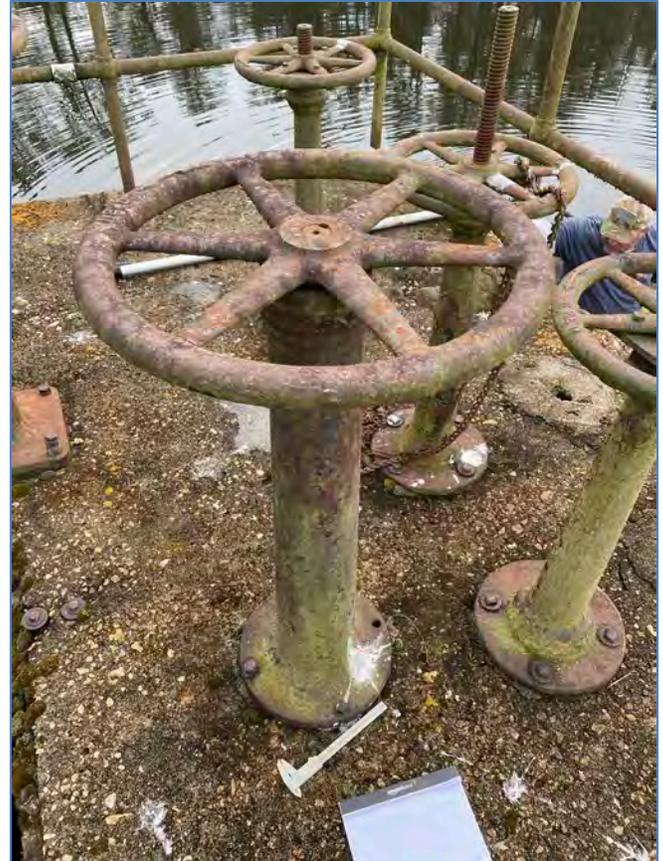
Figure 52 - 24" Bottom Drain Operator

Gate 4 is controlled by a large handwheel operator located on top of the tower. A position indicator is built into the side of the operator pedestal. The indicator shows the gate to be $\frac{1}{4}$ open. The diver was not able to confirm the position of the valve because it is a self-contained bonneted inline valve. A mild steel stem travels down from the operator to the gate valve. The stem is broken at the waterline and heavily corroded below the water level. The stem travels down to a system of gears. The stem is offset to the left of the gate valve/water supply line centerline.

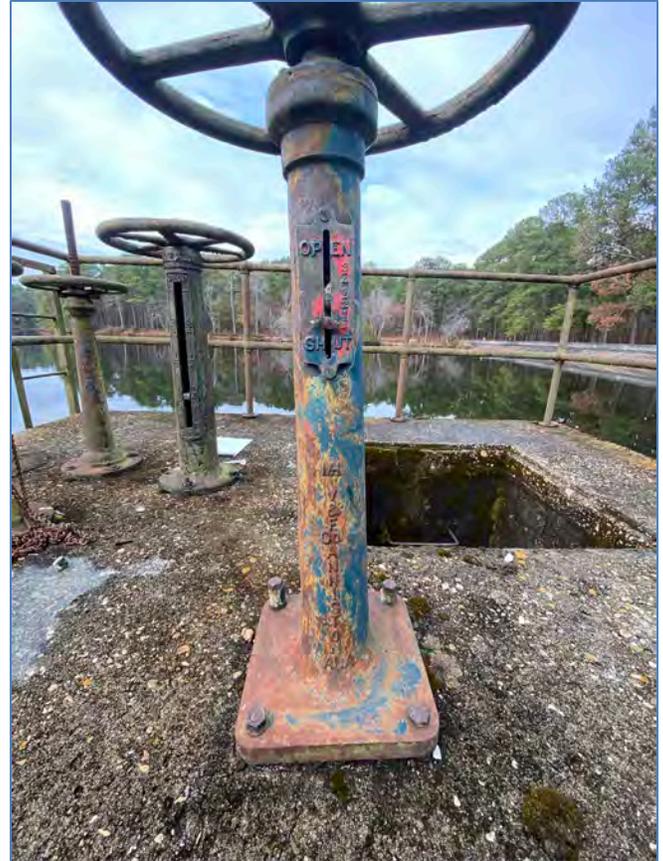
Figure 61 - Gate 5 Operator, note pedestal indicator ¼ open

The valve was found in the fully closed position as reported by the diver; however the pedestal indicated the valve was open ¼.

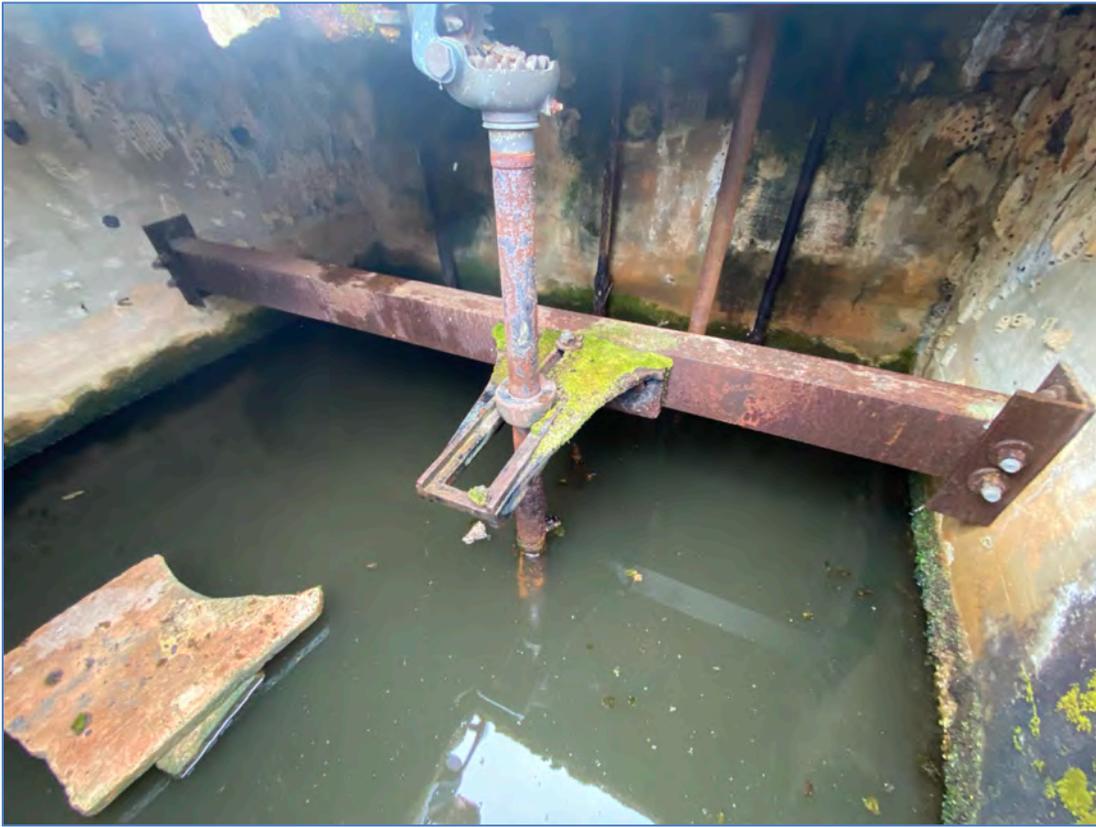
Figure 63 - Gate 5 Stem, Guide, and metal support

The diver reported heavy marine growth and corrosion on all surfaces. Sections of the stem were missing 50% of their original profile, however no areas were reported to be broken.

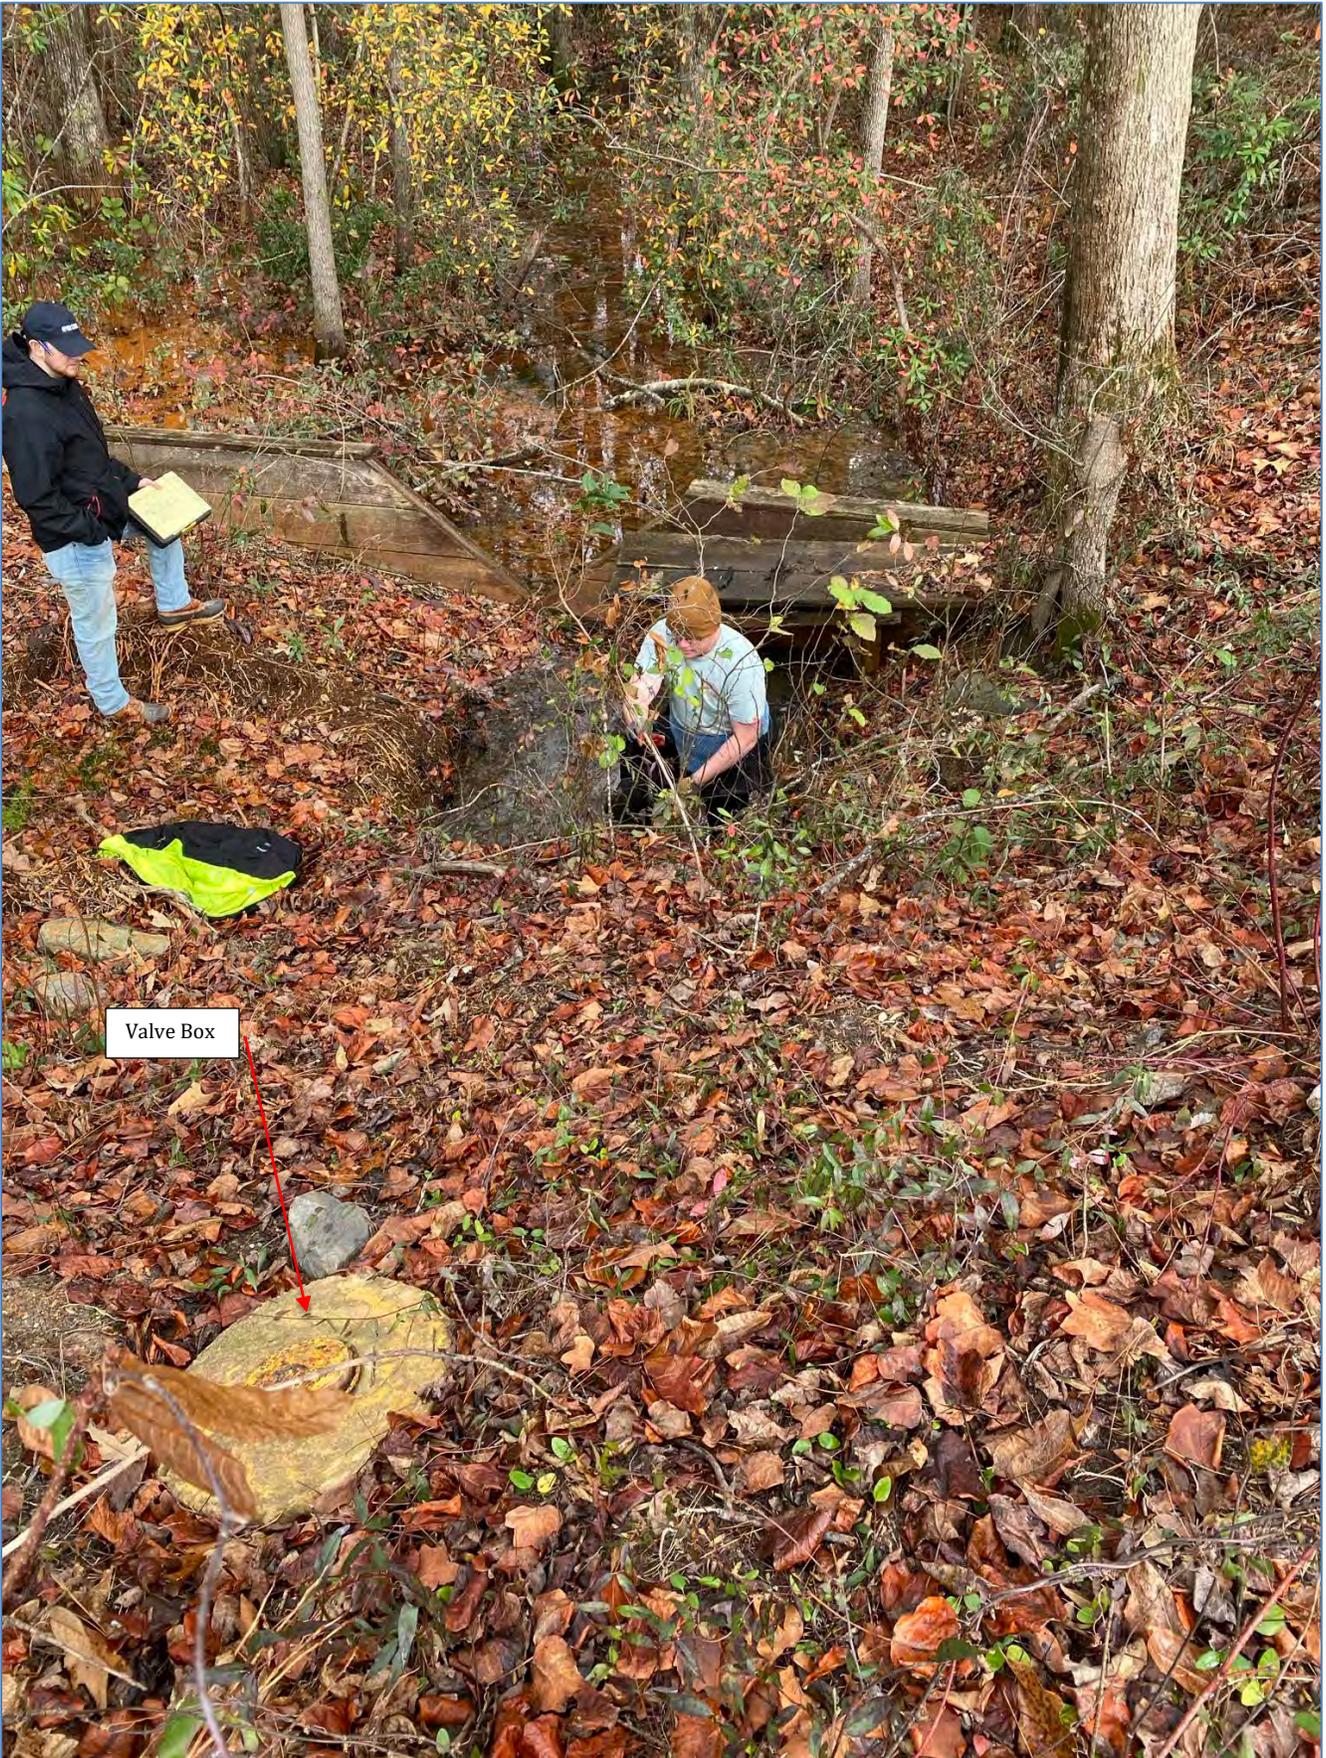
Figure 75 - Crewmember cleaning out and inspecting discharge end of 24" water line

A crewmember got into the small pool at the toe of the dam and was able to confirm a roughly 24" metal pipe projecting through a concrete end wall. One to two inches of sediment was noted in the pipe, but overall, the pipe was open. Roots and vegetation were growing into the pipe. The top of the pipe was under roughly 12 inches of water. The downstream channel appears to be much higher than when originally installed, likely due to sediment build-up.

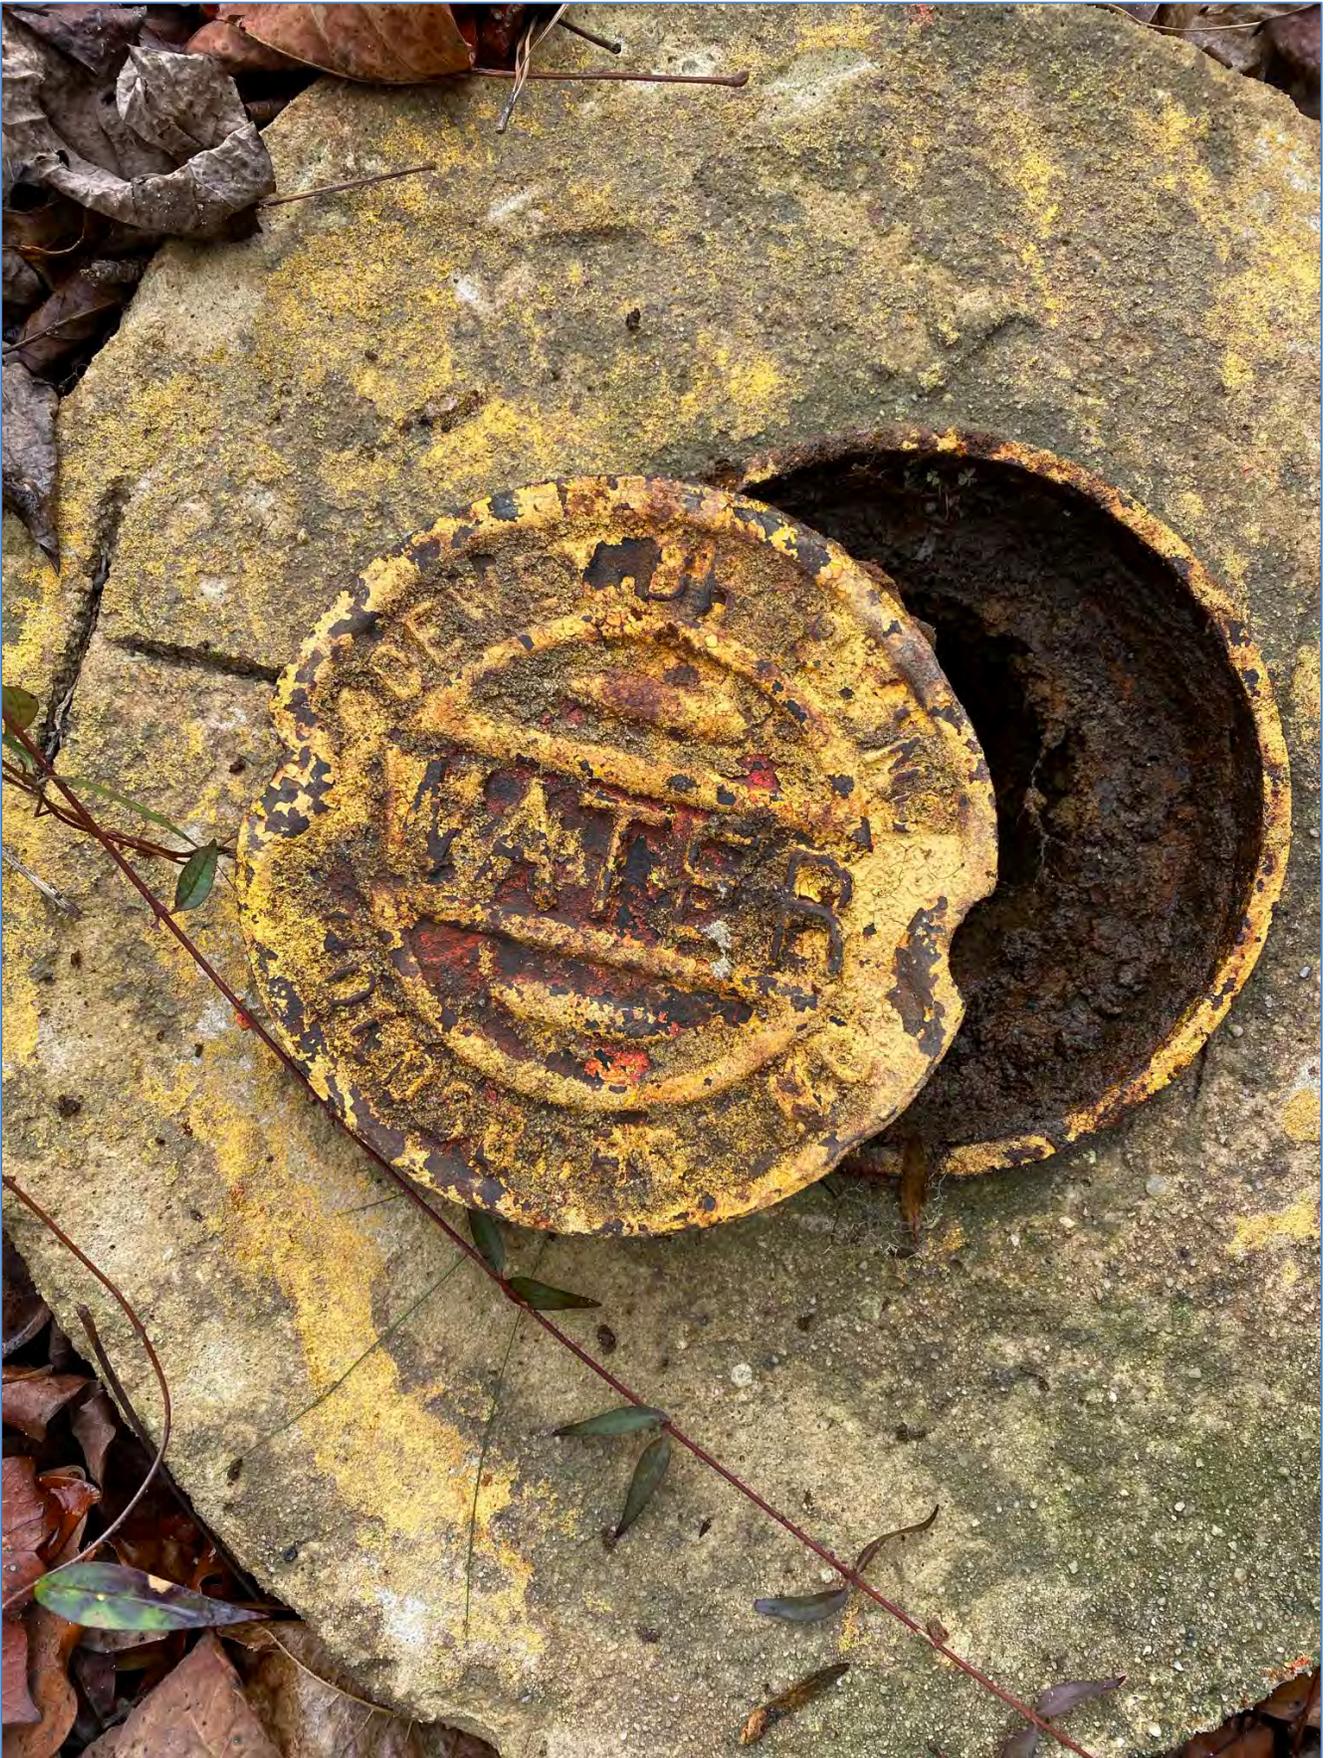
Figure 76 - Top of Water Line Valve Box

A valve box was observed roughly 15' upstream of the discharge end of the pipe. The valve box was offset from the water line by several feet. It is unclear if this is due to the valve box leaning or because of an offset valve configuration, such as a butterfly valve. No operating nut was observed down into the valve box.
