TOWN OF SOUTHERN PINES WATER ASSET MANAGEMENT PLAN

February 2026

NC DEQ Project No. AIA-D-ARP-0062

WR Project No. 02220448.01

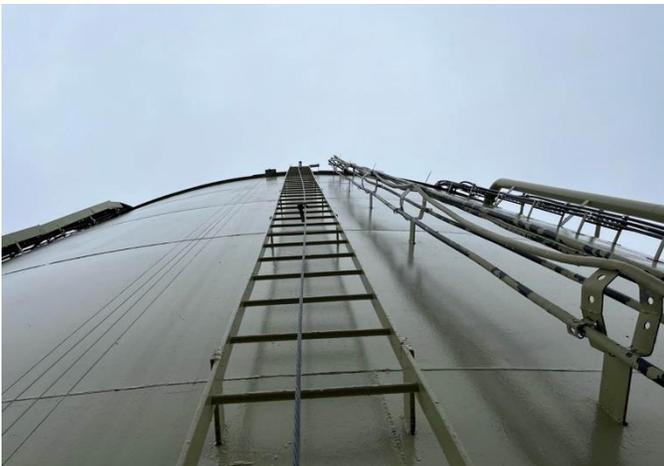
- **Safety Climbing Devices:** Ladders are equipped with secured safety climb devices.
- **Access Hatch1:** No deficiencies noted.

Safety Climb on Access Ladder

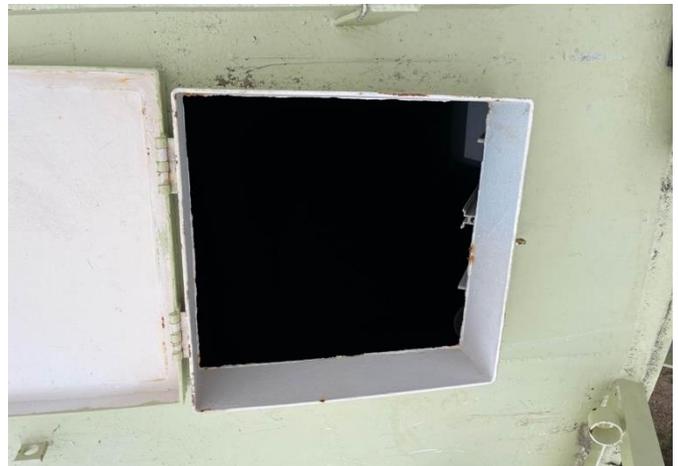
Wet Interior Access Hatch Open

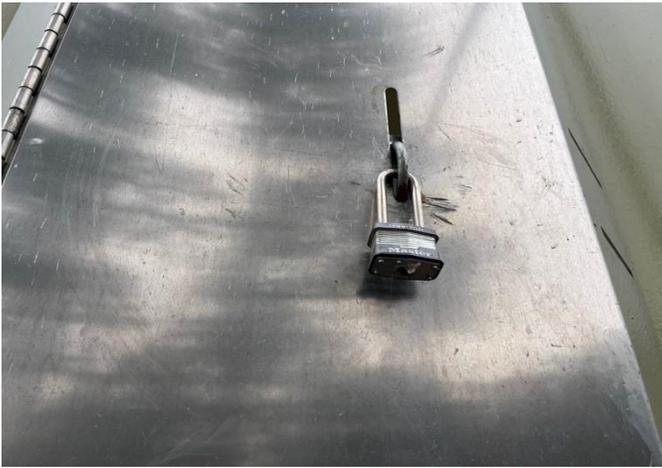
- **Fence Around Site:** Tank is located inside a fenced-in area that is secure.
- **Access Hatch Locked:** Access hatch is locked and secured.
- **Evidence Of Vandalism:** No evidence of vandalism was found.

Ladder Gate Locked

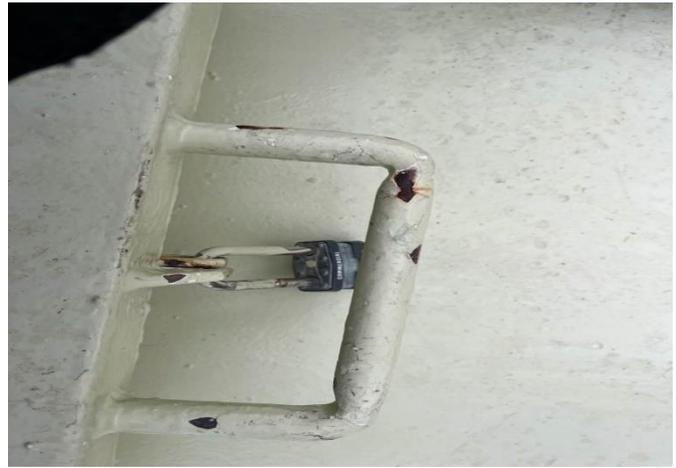
Wet Interior Access Hatch Locked

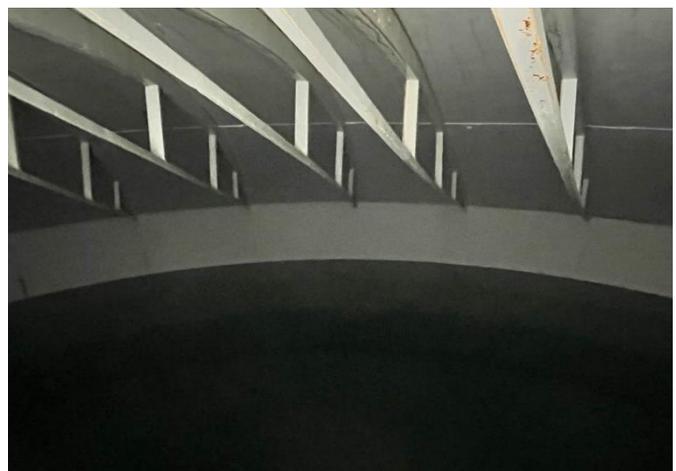
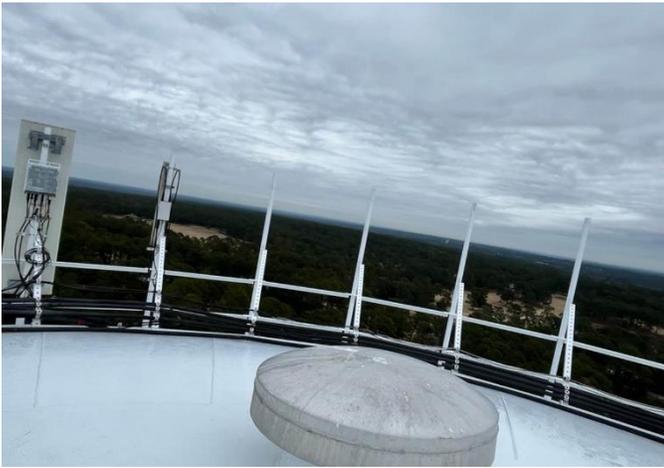
Interior Roof and Sidewall Coating

- **Interior Coating Condition:** Visible areas of the interior coating are in good condition and continues to protect the substrate.
- **Exterior Coating Condition:** No deficiencies noted in the exterior coating.
- **Dry Interior Condition:** No deficiencies noted in the dry interior coating.

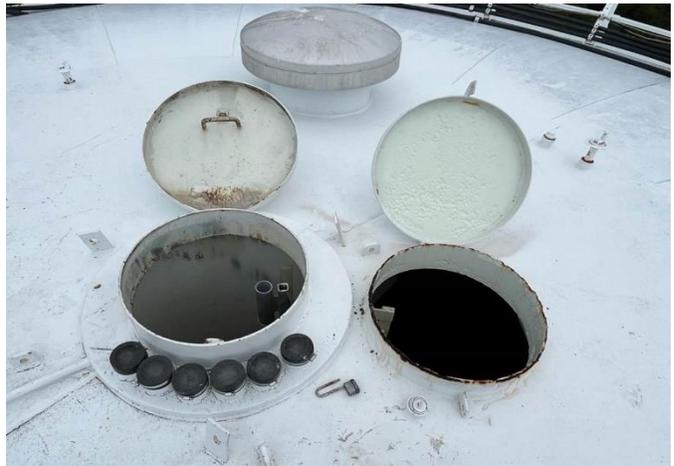
Wet and Dry Interior Roof Access Hatches

- **Safety Climbing Devices:** Ladders are equipped with secured safety climb devices.
- **Access Hatch1:** No deficiencies noted with the dry interior roof access hatch.
- **Access Hatch2:** Minor deficiencies noted with the wet interior roof access hatch. We will continue to monitor these areas.

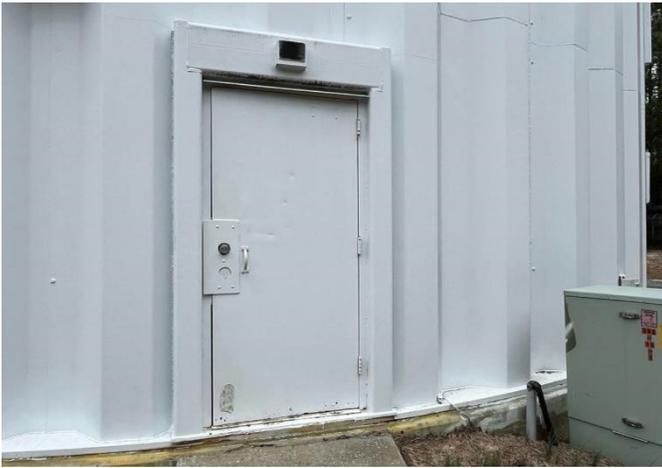
Locked Tank Access Door

- **Fence Around Site:** Tank is located inside a fenced-in area that is secure.
- **Ladder Gate/Access Door:** Tank has a door access to the interior dry ladder and the door was locked.
- **Access Hatch Locked:** Access hatch is locked and secured.
- **Evidence Of Vandalism:** No evidence of vandalism was found.

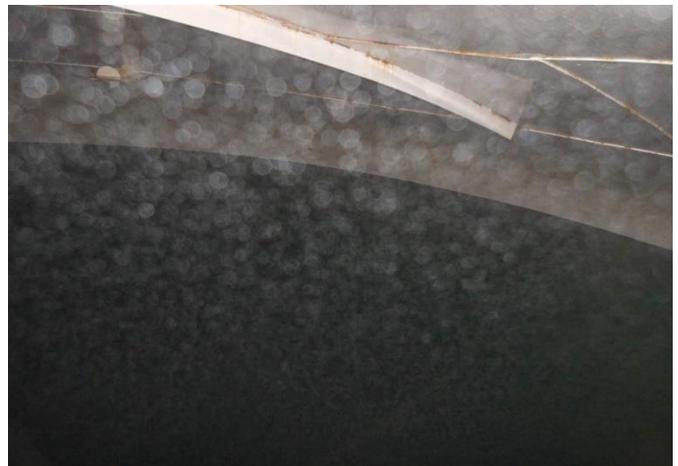
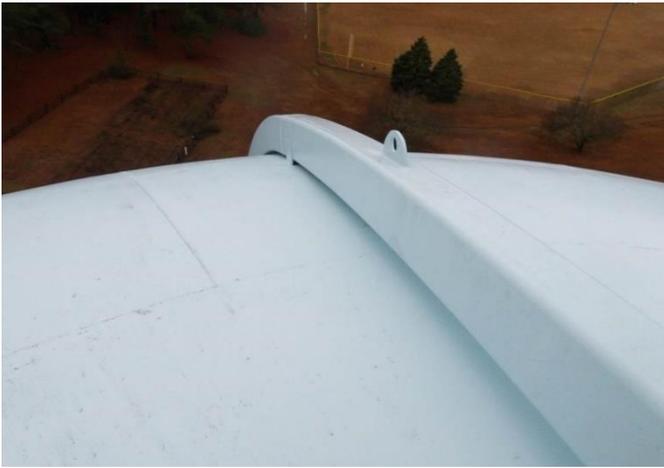
Interior Roof and Sidewall Coating

- **Interior Coating Condition:** Interior coating is in overall good condition and continues to protect the substrate. Corrosion and rust deficiencies noted with the roof. Due to the contract schedule, an interior renovation is tentatively scheduled.
- **Exterior Coating Condition:** No deficiencies noted in the exterior coating.

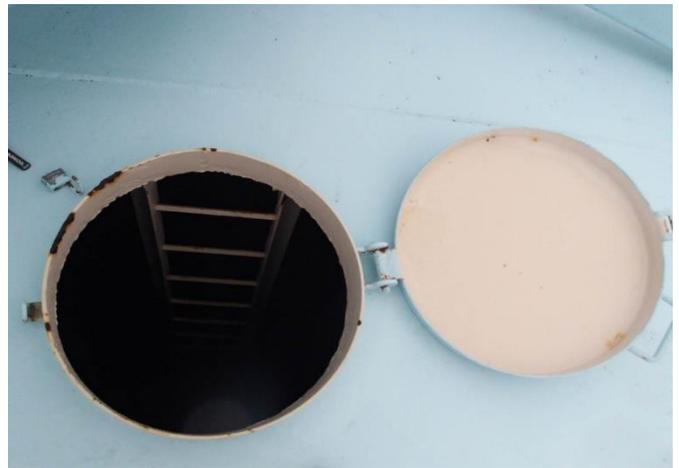
Roof Access Hatch Open

- **Safety Climbing Devices:** Ladders are equipped with secured safety climb devices.
- **Access Hatch:** Corrosion deficiencies noted on the interior portion of the access hatch. Areas will be addressed at the tentatively scheduled interior renovation.

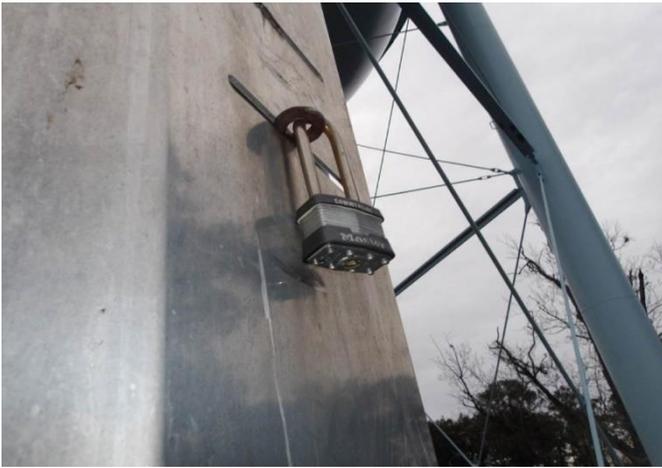
Locked Ladder Gate

- **Fence Around Site:** Tank is located inside a fenced-in area that is secure.
- **Ladder Gate/Access Door:** Exterior ladder has a ladder gate installed and is locked.
- **Access Hatch Locked:** Access hatch is locked and secured.
- **Evidence of Vandalism:** No evidence of vandalism was found.

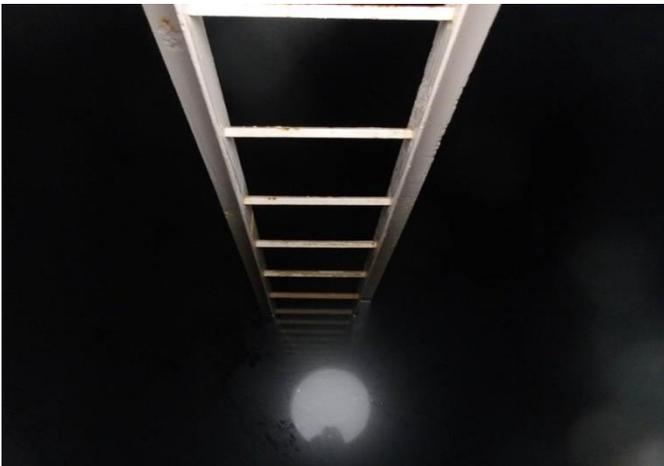
Interior Ladder

- **Balcony:** No deficiencies or corrosion damage noted for balcony railings and landings.
- **Interior Ladders:** Interior ladder partially inspected from hatch. No deficiencies noted with visible portion of ladder.

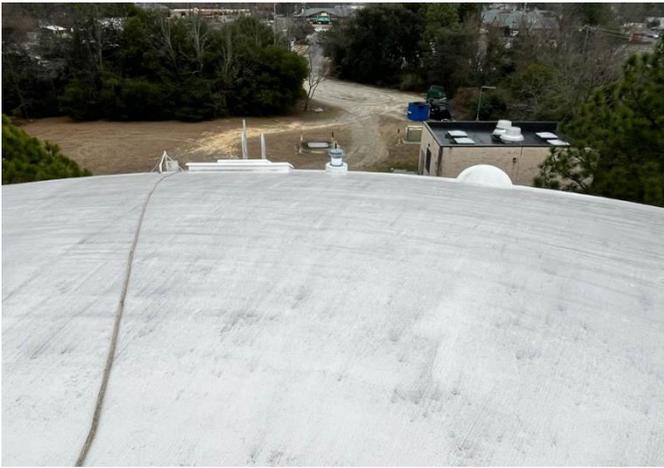
Interior Condition

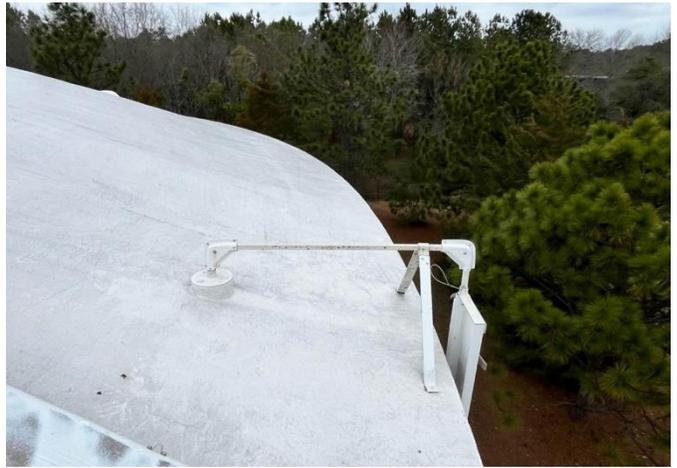
Exterior Roof Coating

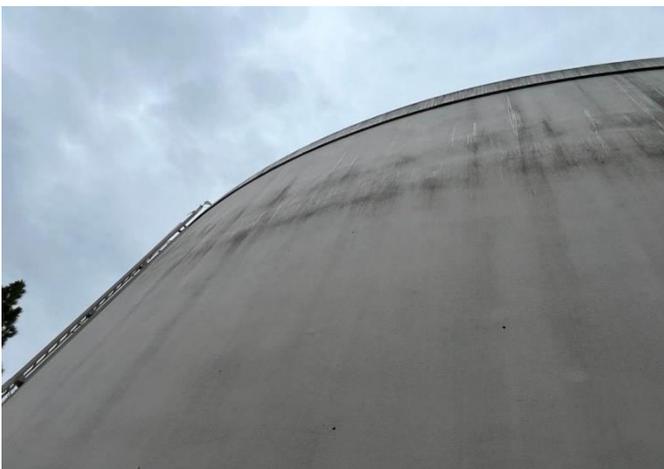
Exterior Roof Coating

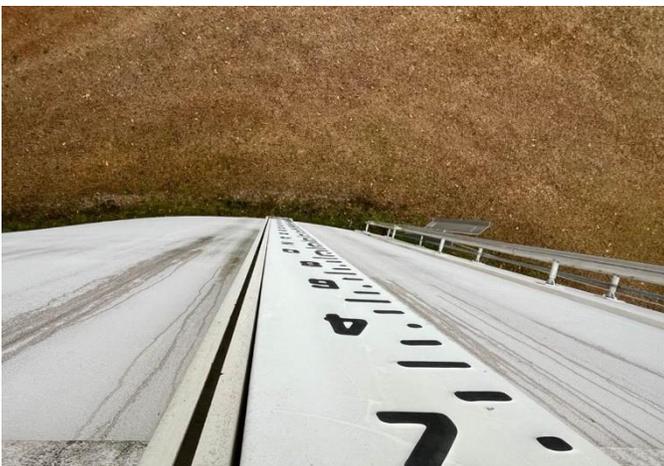
Exterior Sidewall Coating

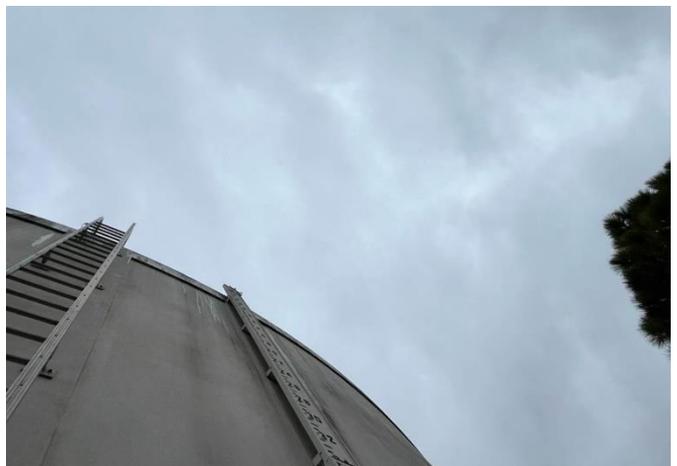
Exterior Sidewall Coating

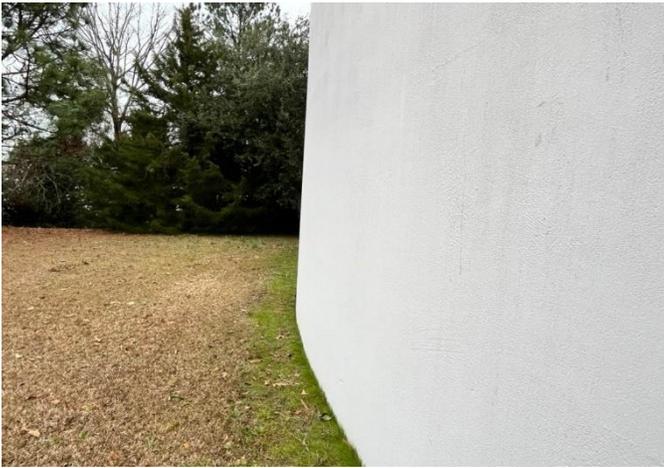
Exterior Sidewall Coating

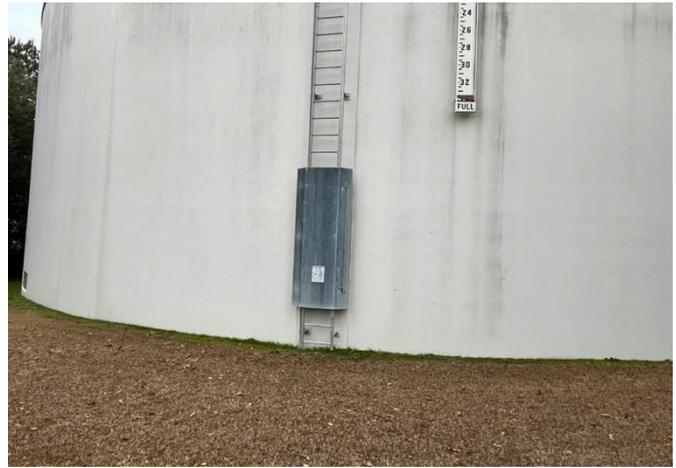
Exterior Base Coating

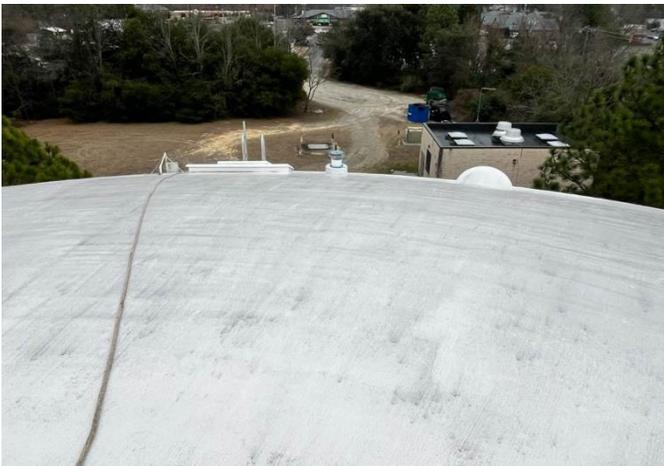
- **Access Hatch1:** No deficiencies noted.

Wet Interior Access Hatch

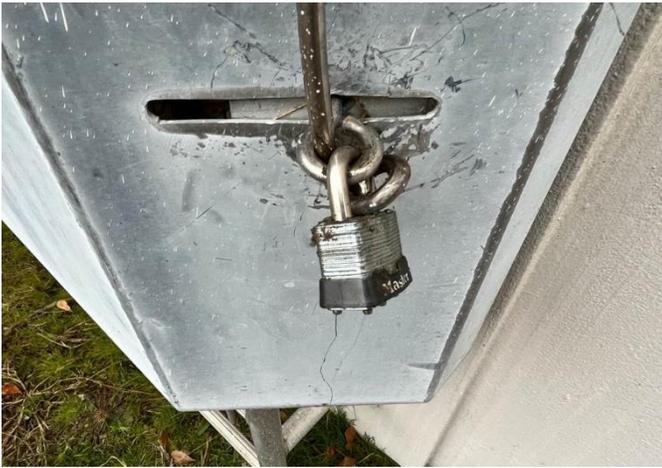
- **Fence Around Site:** Tank is not located inside a fenced-in area.
- **Ladder Gate/Access Door:** Exterior ladder has a ladder gate installed and is locked.
- **Access Hatch Locked:** Access hatch is locked and secured.
- **Evidence Of Vandalism:** No evidence of vandalism was found.

Ladder Gate Locked

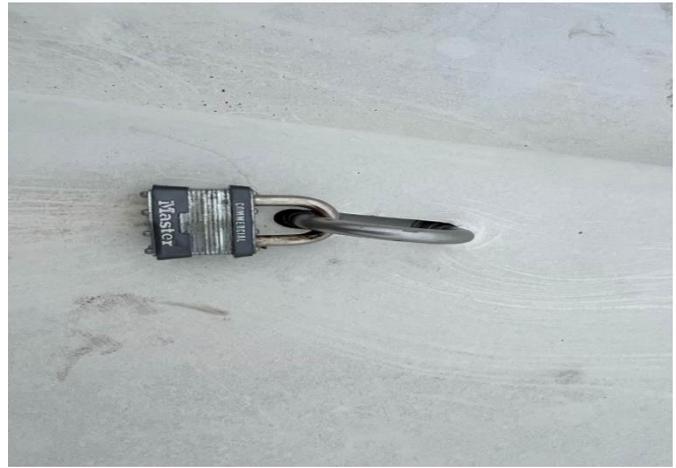
Wet Interior Access Hatch Locked
